ADDRESS DELETED

SAN ANTONIO, TX 78219

This inspection consists of several buildings located at the same address. The space consists of office space, storage, and commercial work space.

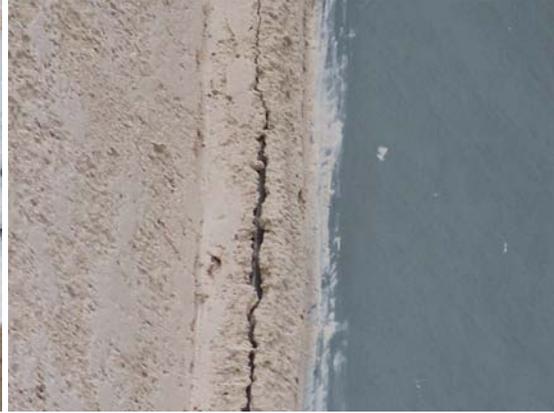
Flashing not sealed on side of column

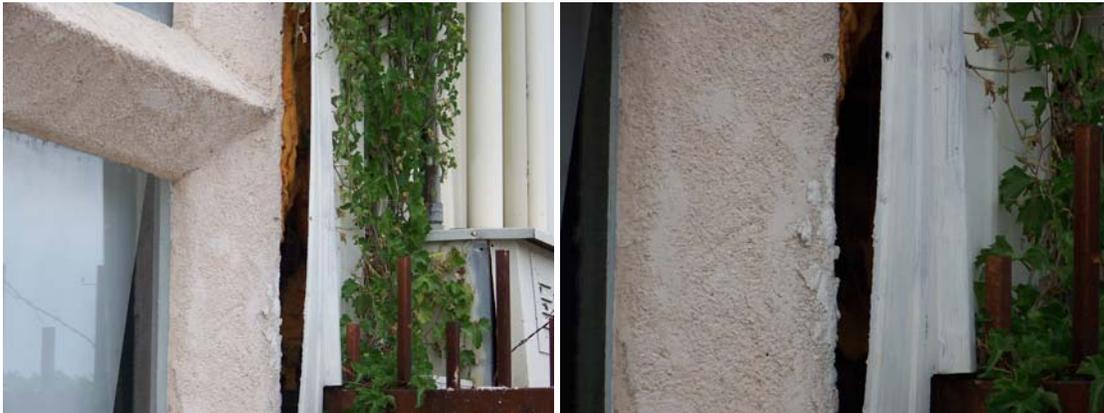
View of metal to stucco seam on the right side of the building. The metal needs to be properly secured and sealed to the stucco wall to prevent water penetration.

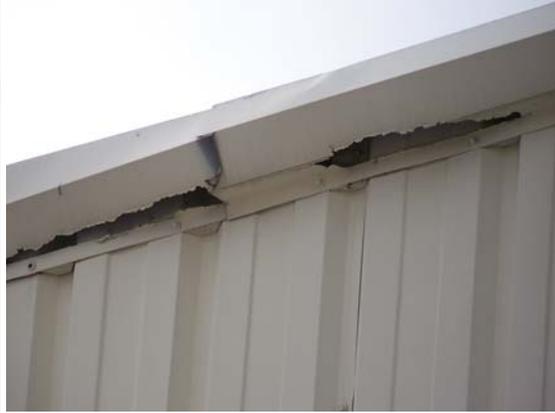
Wall open at corner to building

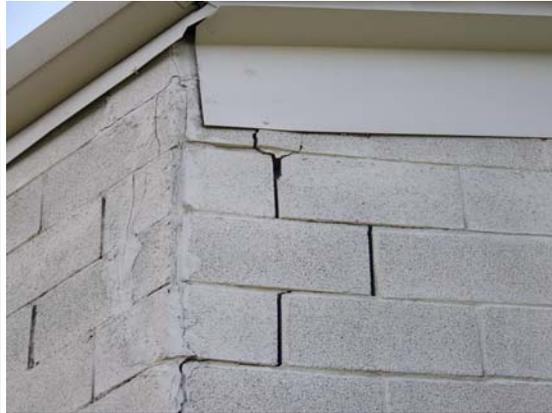
This CMU wall has several settlement cracks. The metal flashing that is placed immediately below the edge of the roof is loose and should be secured.

Loose wall trim at top of wall

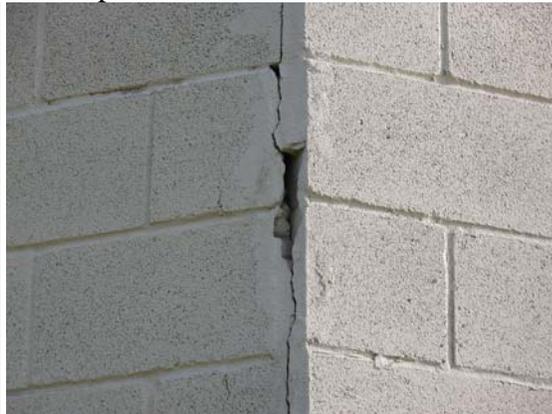
Multiple settlement cracks in CMU wall

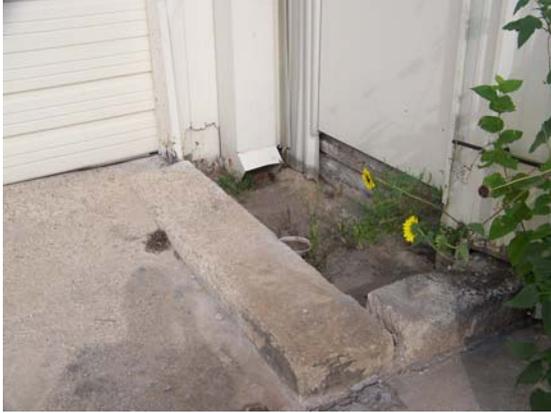
The back storage area has a large gutter dumping into a concrete “trough” at the corner of the garage and warehouse, with no additional drainage present. Water marks on the foundation and metal indicates that the water reaches a level high enough to enter the building during heavy downpours.

Gutter leading into "trough"

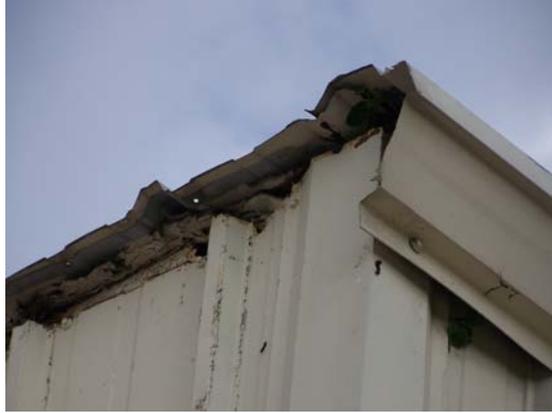
Back left corner of wall/roof covering

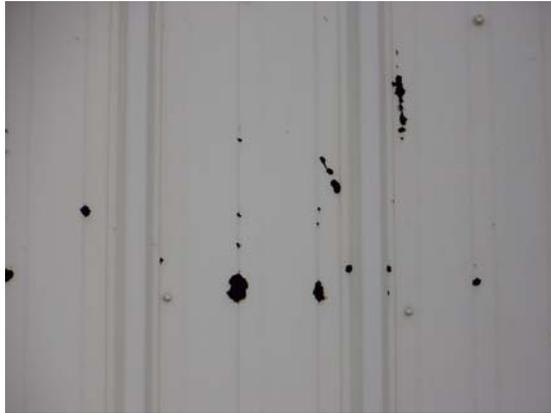
The back section of the building on the left side has numerous perforations due to corrosion and physical damage that should be properly repaired.

Corrosion perforations in wall metal

Replacement of some of the metal may be required due to the extent of the damage and the number of patches that are not properly installed on the exterior wall.

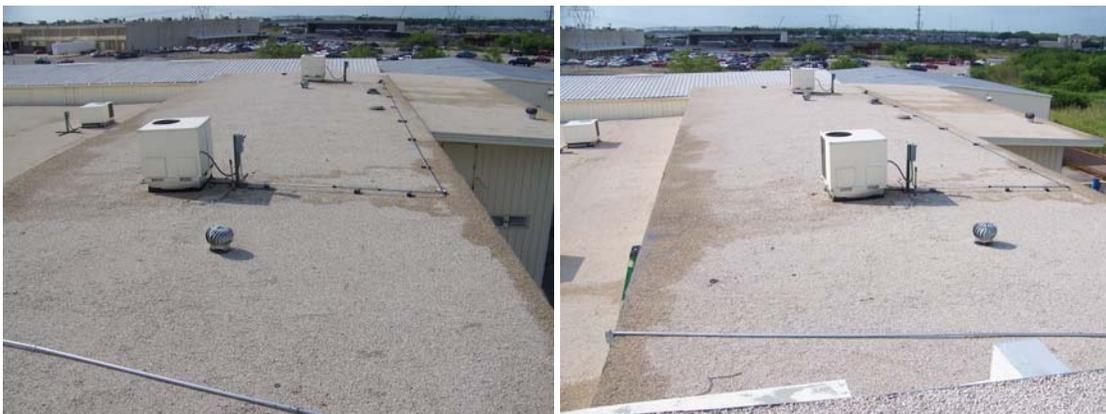
The A/C condensing units located on this roof are draining condensate directly onto the roof surface. The water is ponding at the roof edge and at several locations on the surface of the roof. These units should have drain lines to the gutter area or to the edge of the roof.

A/C units shown depositing condensate on the roof surface

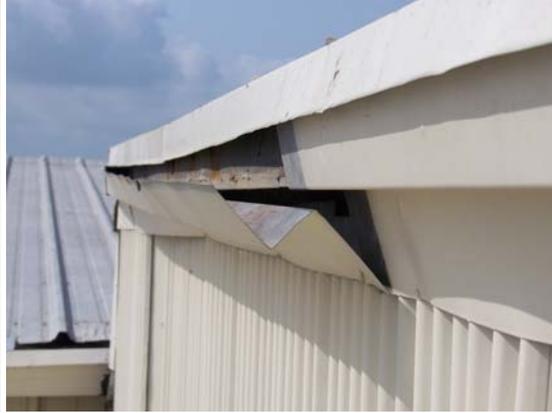
This tar and gravel roof appears to have less than a 1:12 pitch from the center to each side. The aggregate distribution is uniform with no bare areas except near the right front edge where the roof intersects with the upper wall. The flashing is loose at the roof edge at this location and should be repaired.

Loose trim at roof flashing

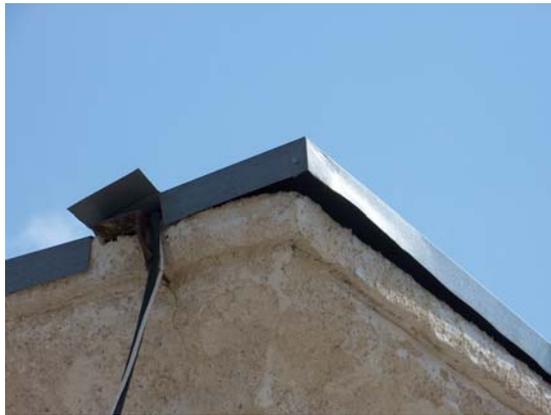
The sealing (flashing) around the back side of the columns on the front side of the roof appear to be satisfactory. One of the metal covers for the column at the left front corner is loose and should be secured and sealed.

Loose covering on top of corner column

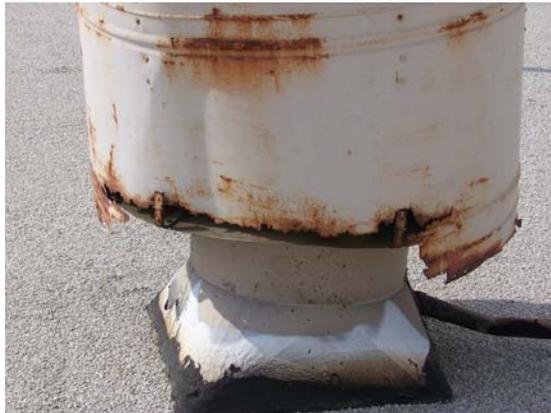
Defective range hood cover

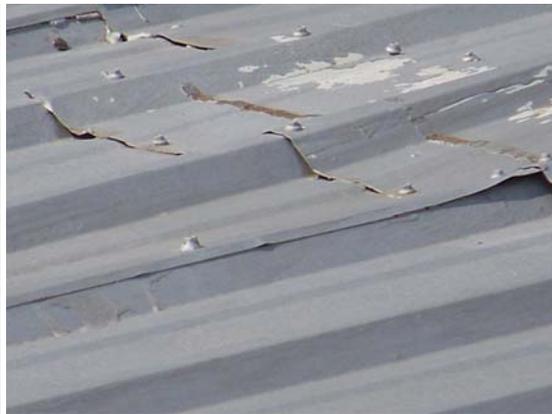
Small repaired areas near ridge

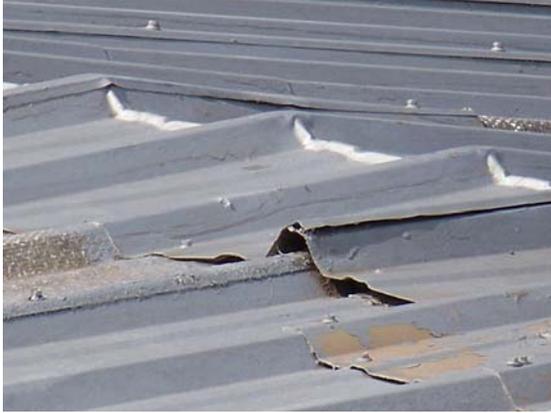
This metal roof cover has fiberglass panels (translucent) to allow light in to the building. Numerous repairs near the ridge have resulted in open areas where blown rain will access the building. The large gutter running along the edge of the building at the larger warehouse wall was not completely visible. Debris was present in the gutter area and should be removed. There was evidence of water penetration at the gutter area where the roof terminates into the side of the warehouse wall. Inspector does not know whether the leak has been repaired or whether it is still present.

Loose panels near center ridge

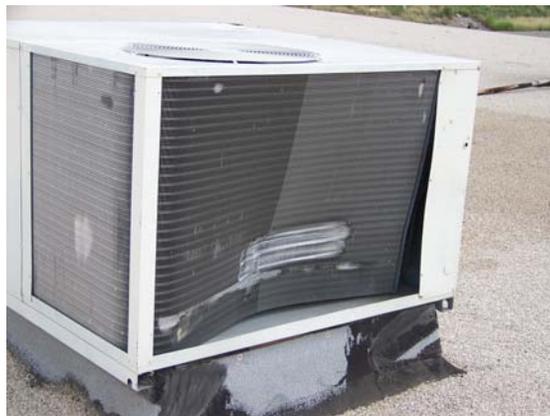
UNIT #1: This 1991 year model unit had a specification and name plate that was not legible. The unit had a damaged, but functioning coil.

This unit was over the back side of the showroom area. The damaged coil did not effect the units operation

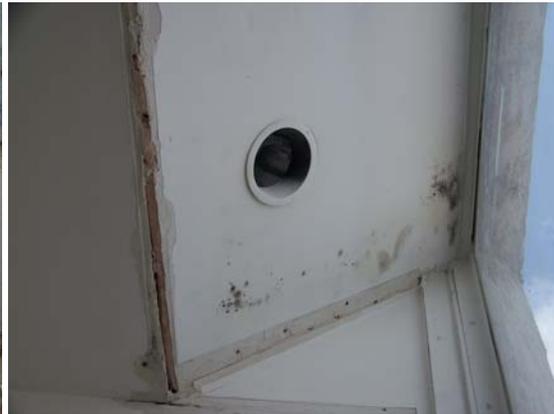
Water damage in ceiling of bathrooms

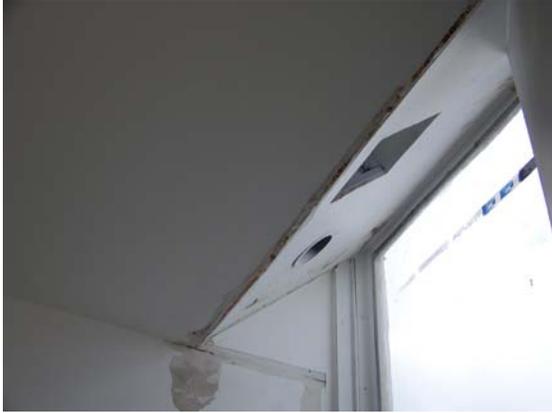
Water damage in bathroom ceiling

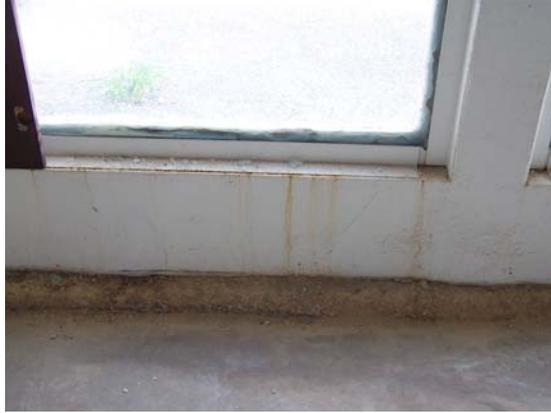
Water penetration from window seals

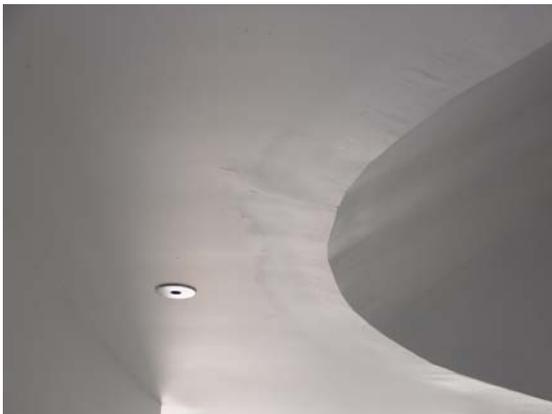
Recent repairs to the ceiling in the lower lobby area indicate that the moisture damage may have been more extensive than the photos indicate.

Repairs in lobby ceiling around stairwell

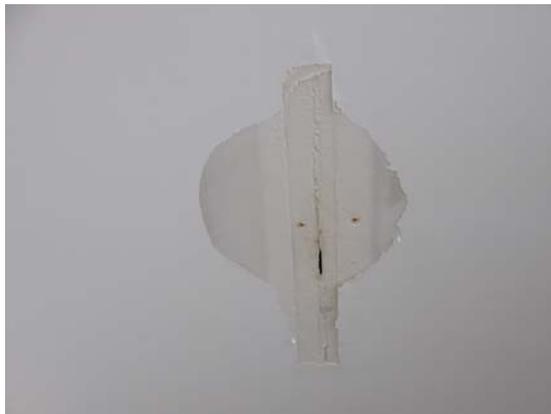
The right side ceiling above the hallway has several areas of water damage. These are below the area where the upper wall and lower roof intersect just to the back of the lobby area.

Water damage area in rt hallway

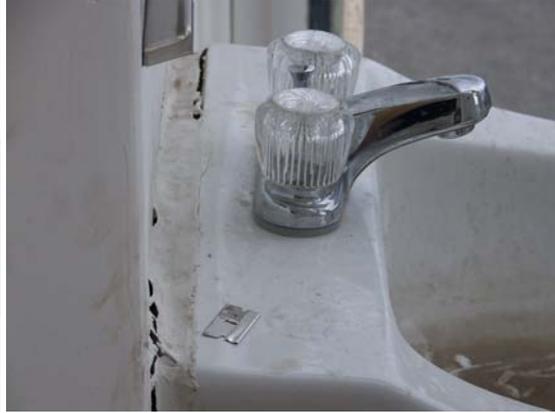
Both toilets were loose and need to be reset. The sink in the right side bath is not secured to the wall.

Sink loose on wall

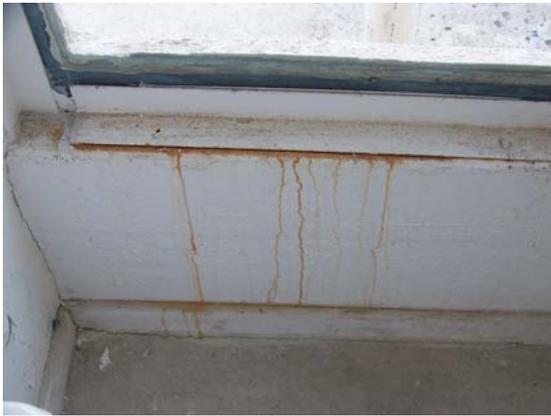
Water penetration around bathroom window and ceiling

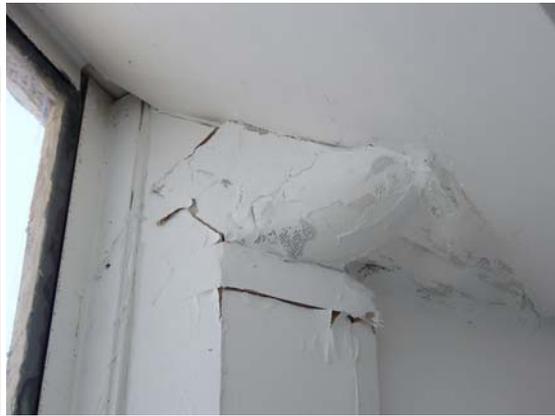
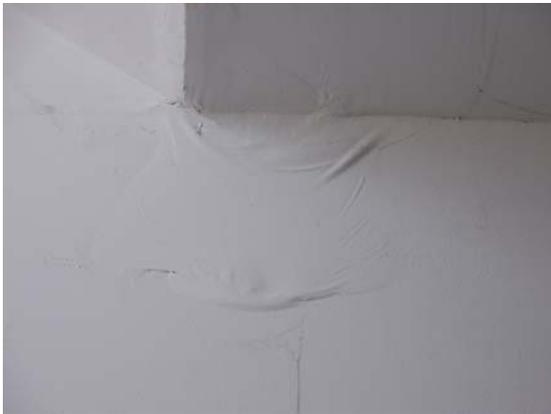
Water damage to wall and ceiling in back and front hallway

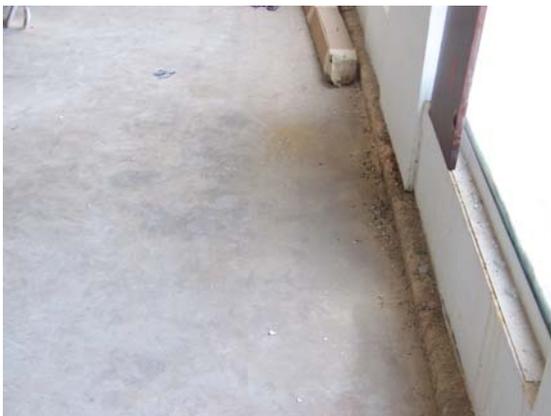
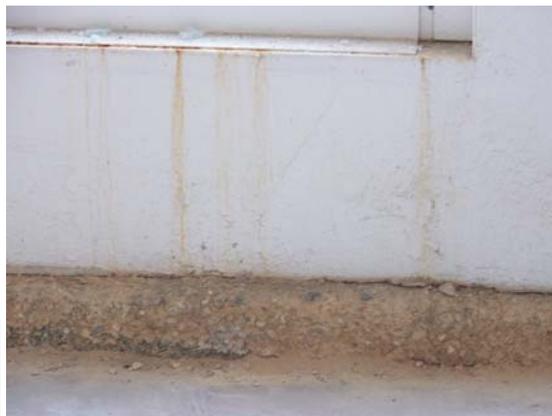
The floor level of the show room is lower than the skirt installed on the outside edge of the building. This has led to water penetration along the front wall that was visible by water stains on the wall and floor. The age of the staining could not be determined.

Water stains at front wall of showroom

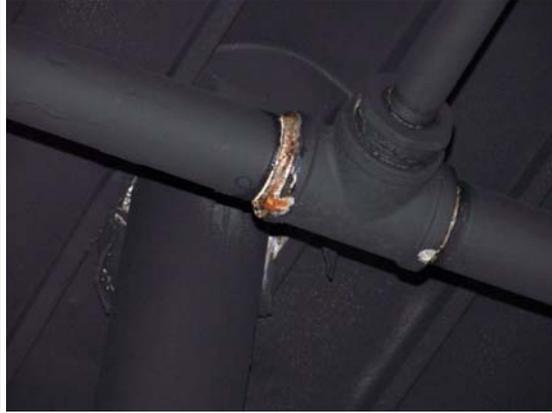
The sprinkler system piping in the back left corner of the show room (in front of the bathrooms) has a leak that should be repaired.

Sprinkler system leak at fitting

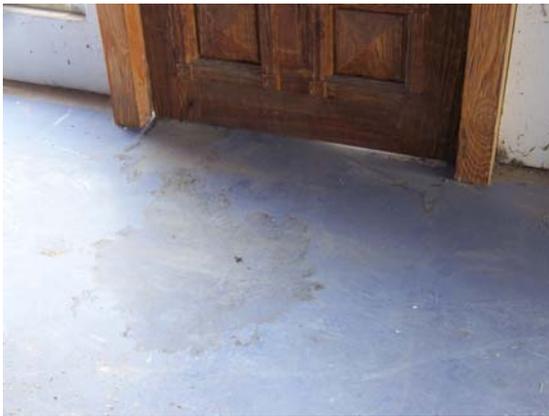
Water stains from under front entry door

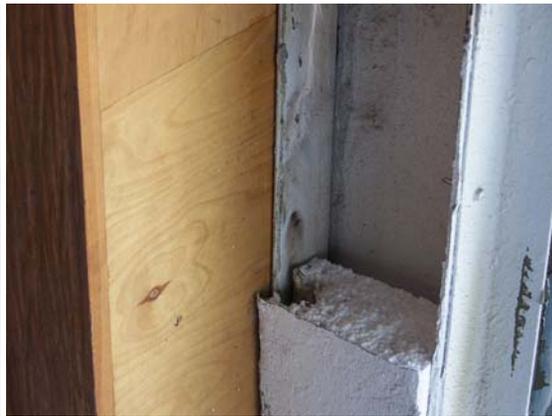
Wood trim and styrofoam by front entry door

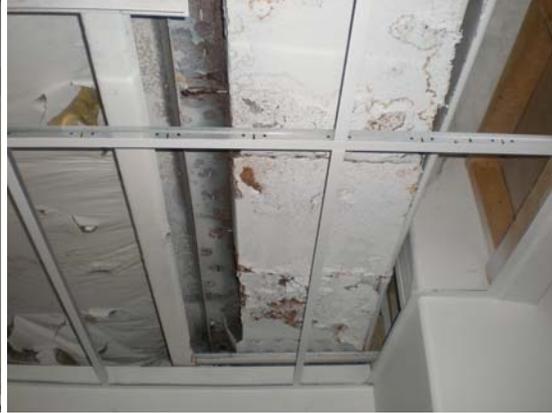
The drywall in the stairwell has water damage from the roof and gutter leaking in this area. The bottom of the gutter itself has stains and rust from condensation or leakage.

Bottom of gutter assembly in hall ceiling

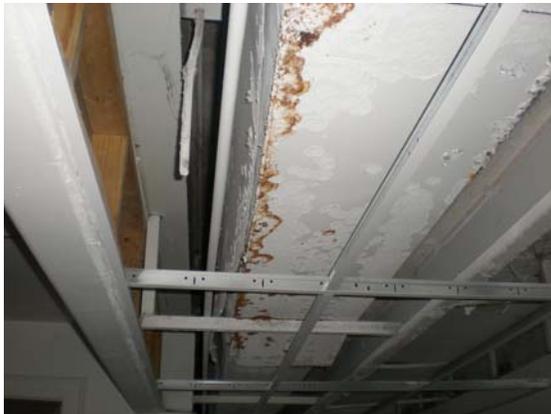
Water stains on bottom of gutter

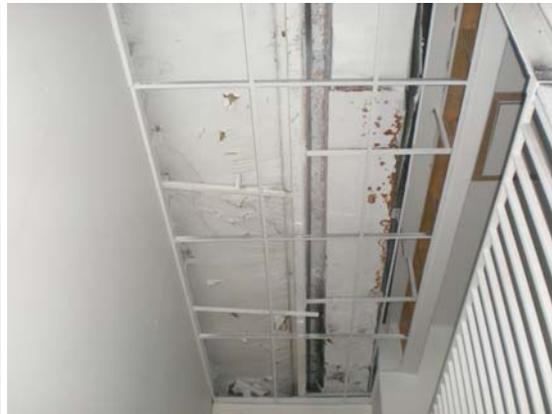
Rusted areas below gutter/roof

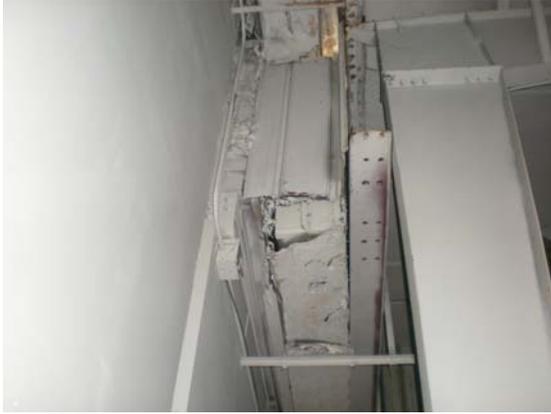
Leakage from the gutter system immediately behind the sewing room has deteriorated the bottom of the main I-beam support framing for the garage roof. (This is actually the support system for the warehouse roof, but is contained in the area that was walled off to give access to the garage from the lower offices.)

Rusted out section of gutter and steel bracing

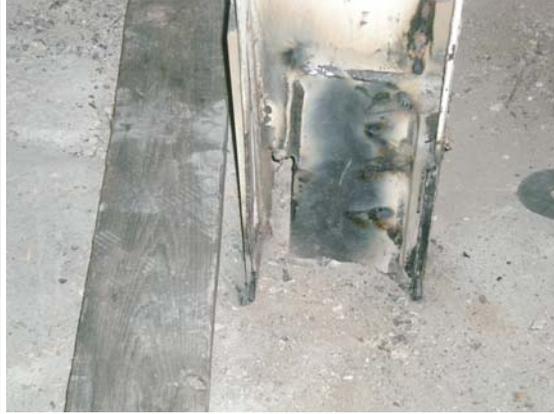
The metal support truss has had some welding patch work performed at the bottom. This repair should be viewed by an engineer familiar with the requirements of steel framed buildings as to the need for additional repair. Repairs to the other metal supports should be done to comply with repair orders issued by the engineer. In their present condition, the beams are not structurally adequate to prevent deflection in the support beam.

Welding work on structural support column

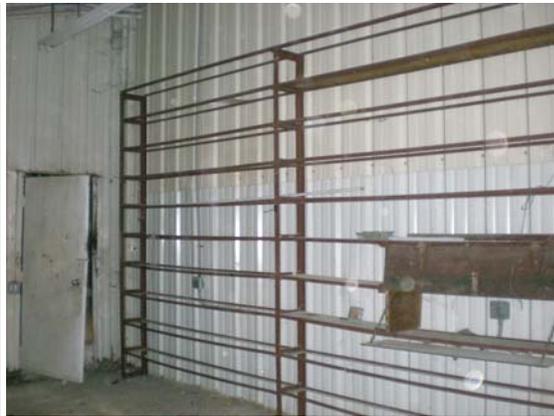
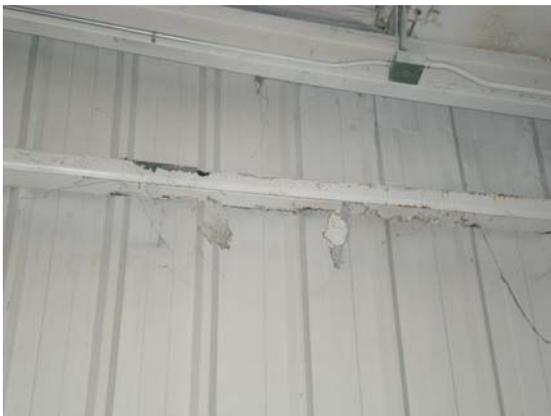
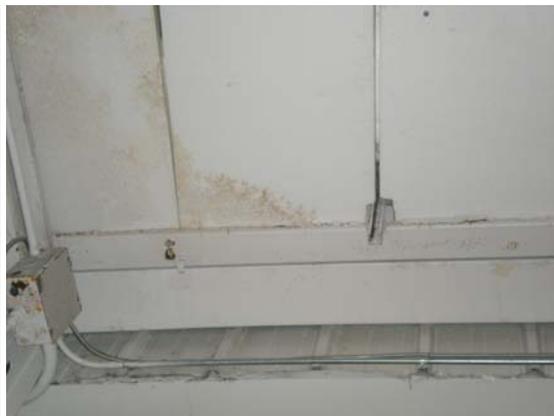
A small door that leads to the isolated garage area on the right side of the building is not secured properly in the building frame. Rusted steel framework and purlin braces were visible in all areas on the front side of the building. The water is believed to be accessing the building mainly from the gutter sections that run between the buildings and between the garage and warehouse area.

Rusted metal purlin supports and water stains in roof support assembly

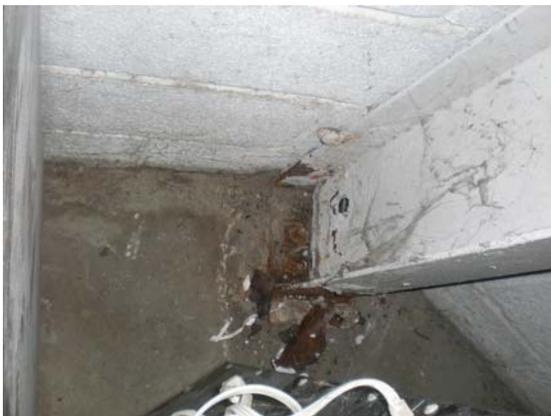
Rust damaged support column in garage

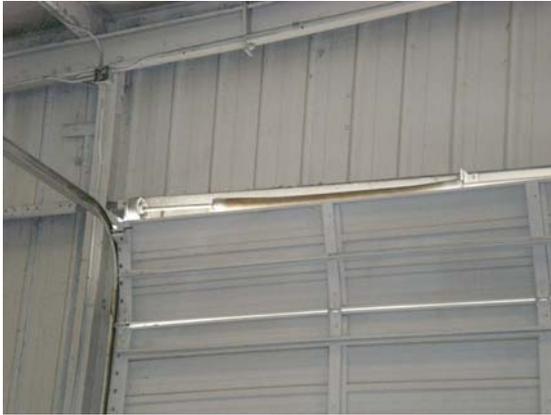
The overhead door to the front of the garage does not appear to be hung properly. The door is sitting crooked in the frame and should be properly secured.

Overhead door is not hung properly

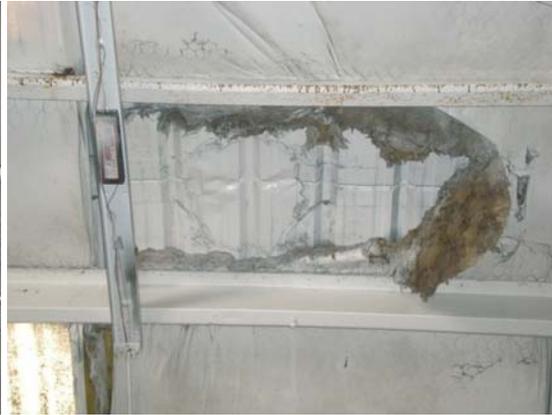
Water damage insulation at ridge

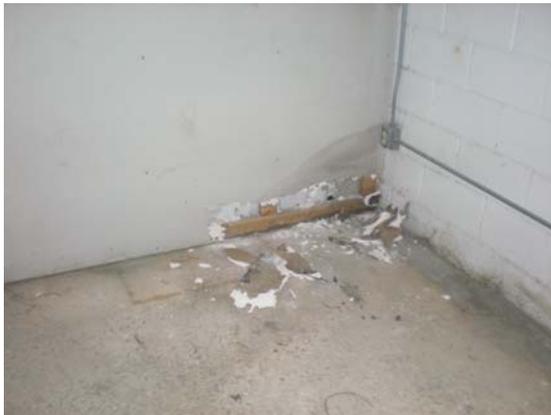
Moisture related damage to drywall in the office area located by the rear overhead door

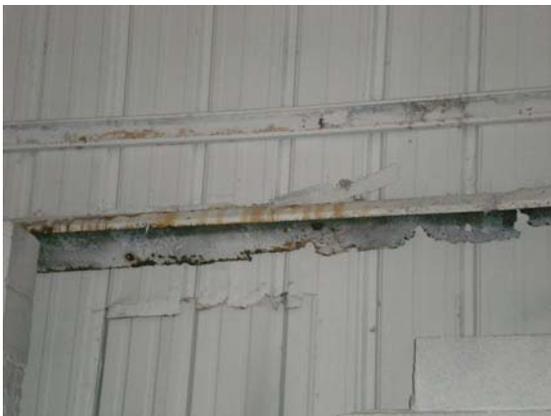
Rusted purlin steel in wall

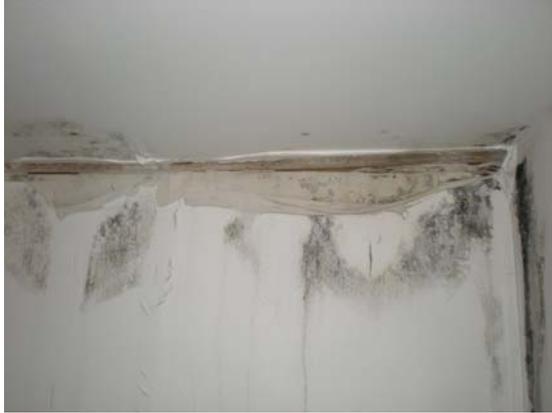
The right side wall of the warehouse has offices and bathrooms constructed. All of these rooms are badly water damaged. Damage in the upper level rooms indicate the water has been coming from the gutter area above the rooms where the warehouse and garage roof tie together. These rooms will need extensive remodeling in order to be used.

Fungal growth and water damage to top level rooms over right side bathrooms in warehouse

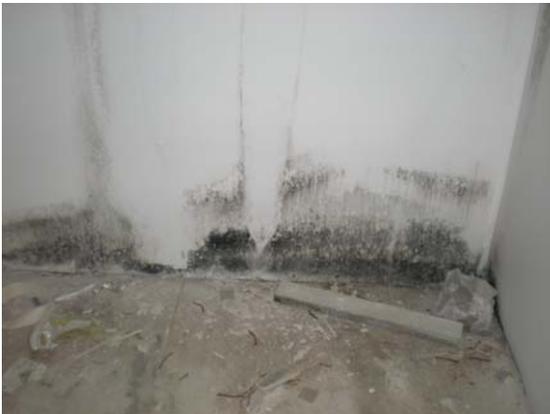
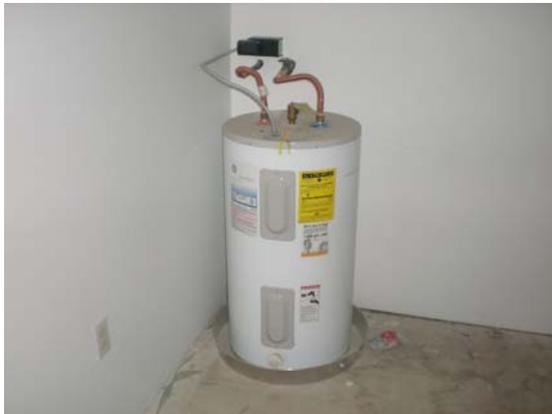
Fungal growth in bottom level rooms on the right side of the warehouse

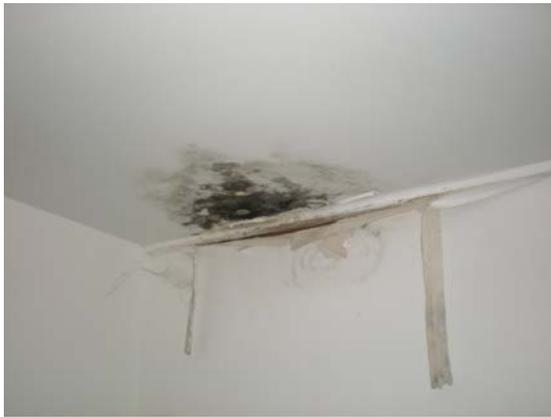
Water damage to the ceiling of the bathroom

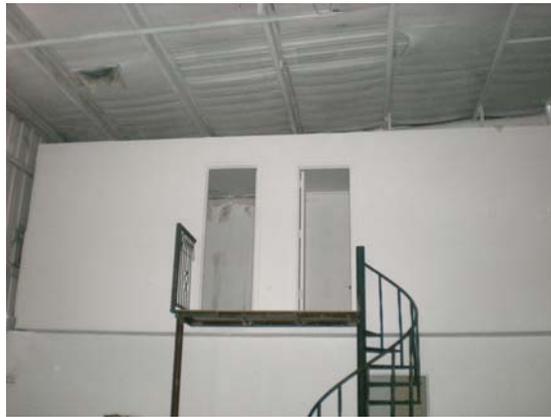
Stairwell to upper level rooms has no guardrail at platform
