PRE DRYWALL INSPECTION REPORT

Concerning: DELETED, San Antonio, TX 78258
(Address of Inspected Property)

By: Kevin Machen, # 5043 10/08/08
(Name and License Number of Inspector) (Date)

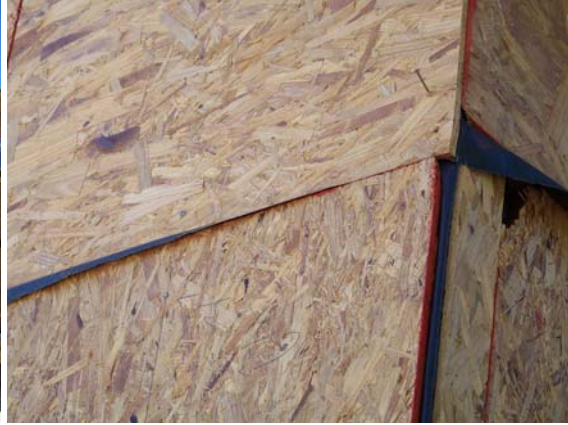
The area of concern is with the horizontal and vertical seams in the OSB being properly flashed and sealed respectively. Some flashing material has been placed between the upper and lower layers of the sheathing, but the vertical seams are still open. These along with numerous holes in the sheathing for wires, pipes, etc., the exterior will need work prior to brick installation.

Flashing not present between sheets

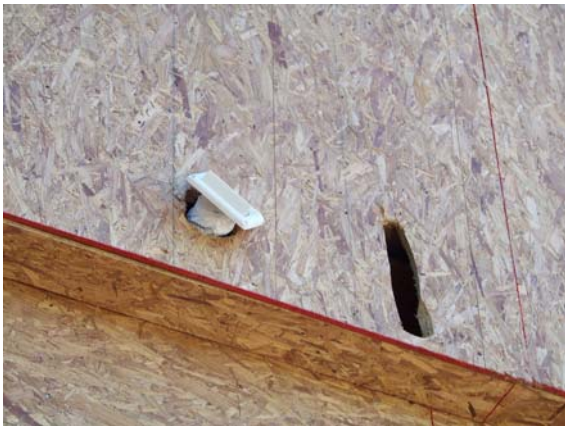
Un-sealed openings in OSB sheathing

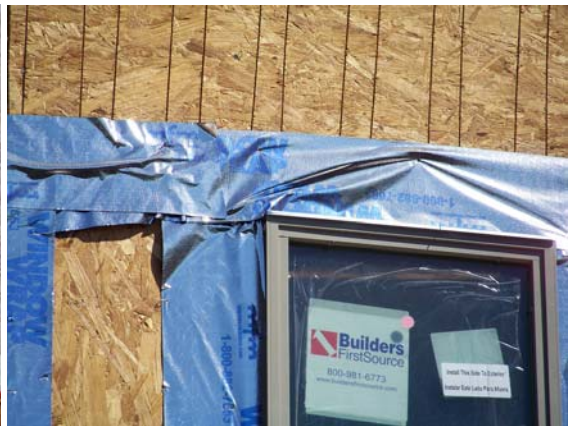
Some of the tape installed around the windows on all sides of the house has loosened due to weather exposure. Any tape that has "released" from the OSB surface should be replaced. All tape manufacturers give limitations in their installation instructions for exposure to weather/sun exposure.

Tape releasing from OSB

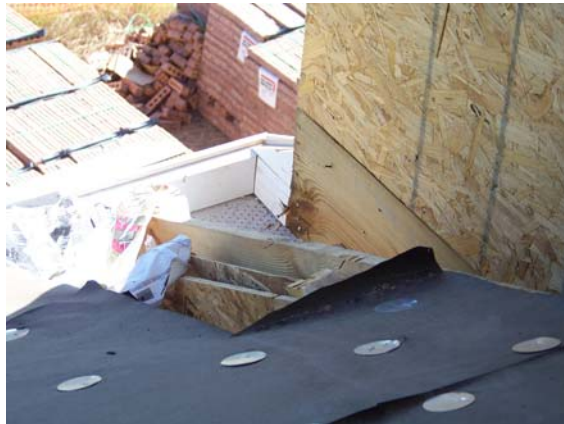
The roof framing and decking does not extend to the right side of the balcony off the game room.

All code reference bodies require that the roof be water tight prior to any insulation and drywall being installed in the structure. The roof should be completed prior to installation of drywall to prevent moisture related problems.

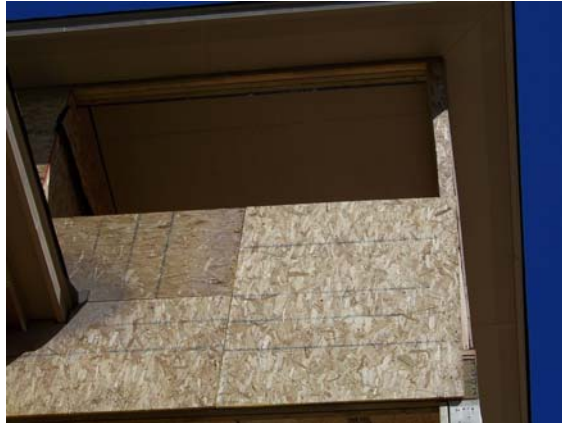
The right side balcony off of the game room has support posts from the ground level and from the second floor level that do not appear to be plumb. The floor on the second floor balcony is pitched slightly for drainage, but the support posts do not appear to be in line for proper support.

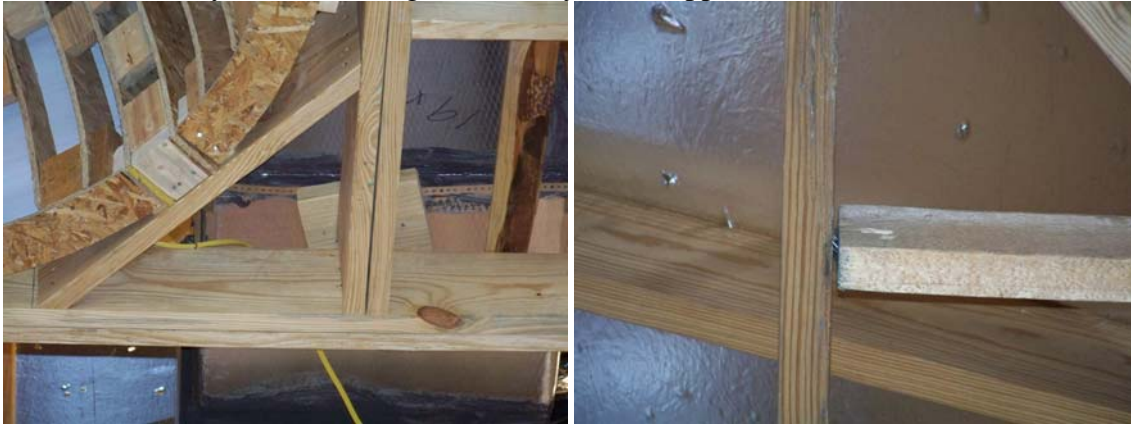
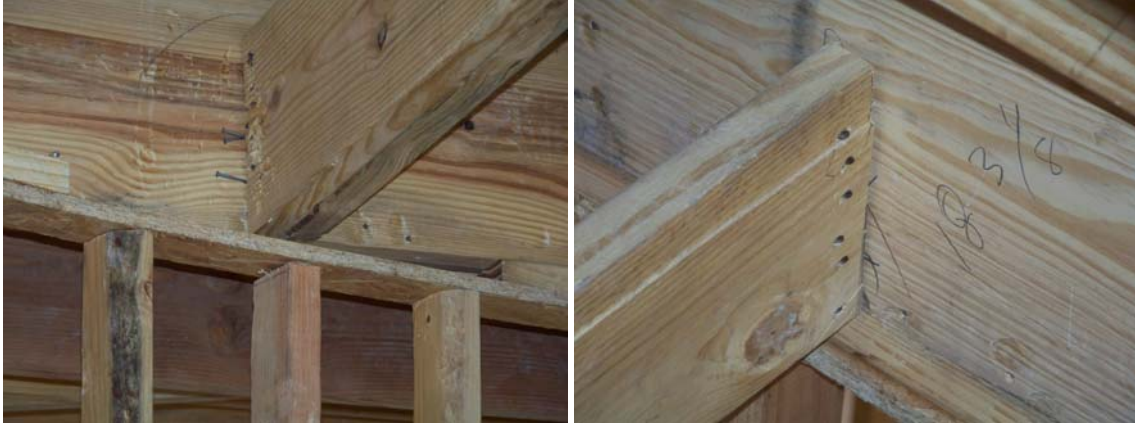
All ceiling joists in the two story front entry that do not rest on the top plate or have direct vertical support need to have metal hangers installed to insure the joists do not settle excessively when the weight of the drywall is applied.

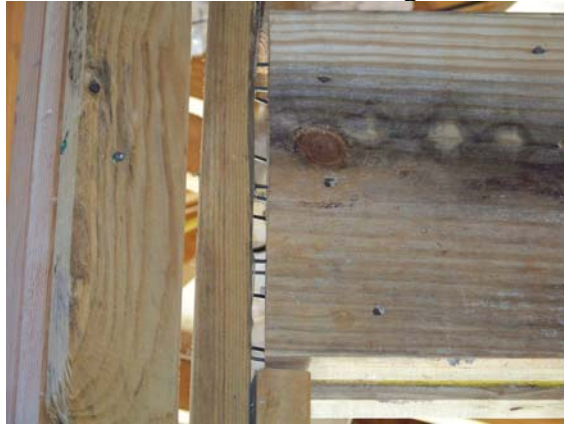
The header over the entry door way to the room on the right side of the front entry is not properly braced. Stud support for the header is inadequate and there has been excessive movement in the stud support due to them not being fastened together adequately. Blocking between the studs is recommended for the right side.

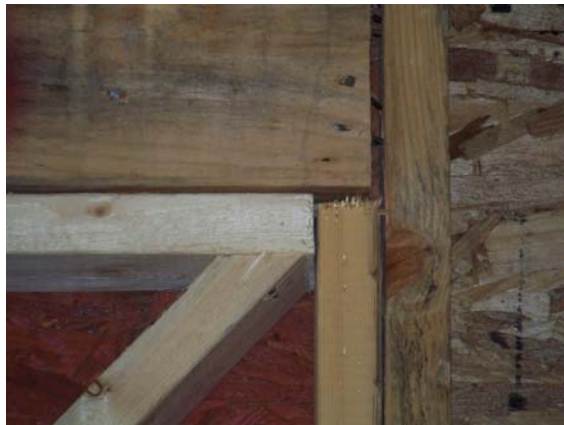
Gaps between the support studs and the small headers over the front windows in the room to the left of the front entry should be shimmed to prevent settlement after drywall installation.

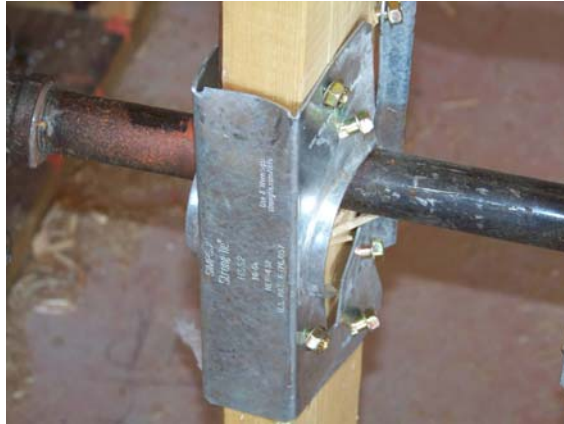
The two-by-six studs in the laundry room/garage wall are very un-even on the nailing surface. This will cause the wall to have waves after drywall installation.

The stud shoes used on the wall by the water heater location are not properly secured to function properly.

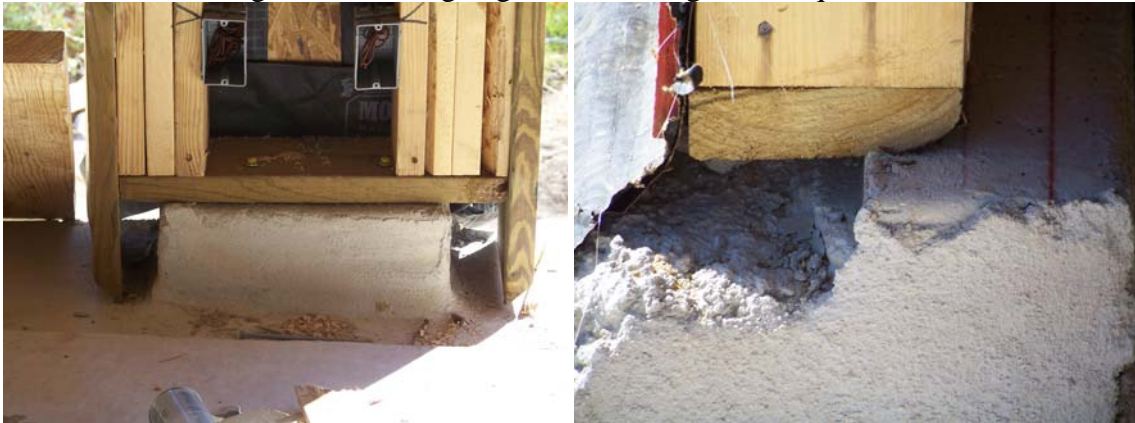
The foundation support for the studs supplying support for the garage door headers in the center and on the right side of the garage door framing is inadequate.

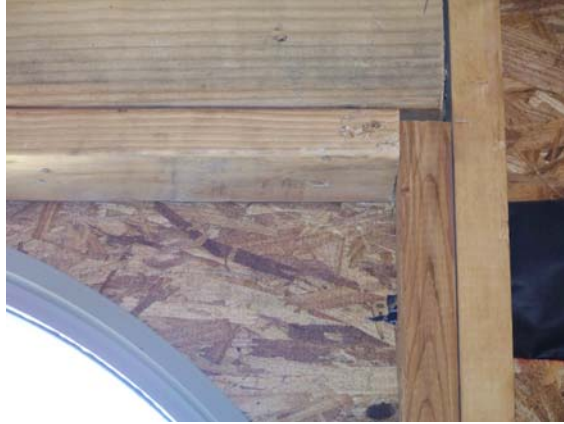
The headers over the windows in the formal dining room have large gaps where the support studs are located. These gaps should be shimmed to prevent settlement.

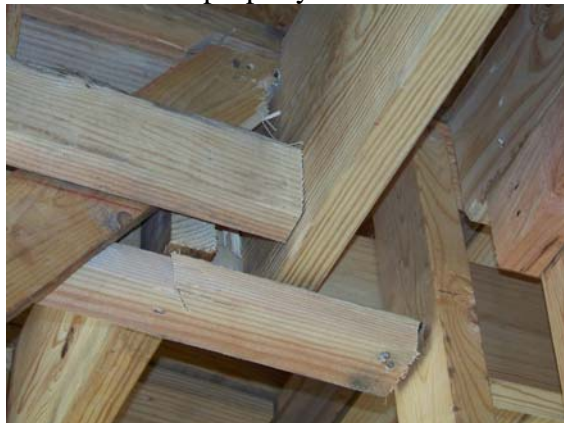
The corners of the box framed ceiling accent in the formal dining room are not adequately secured to the ceiling frame. The two-by-twelve framing that supports the entire box frame structure needs to be properly secured.

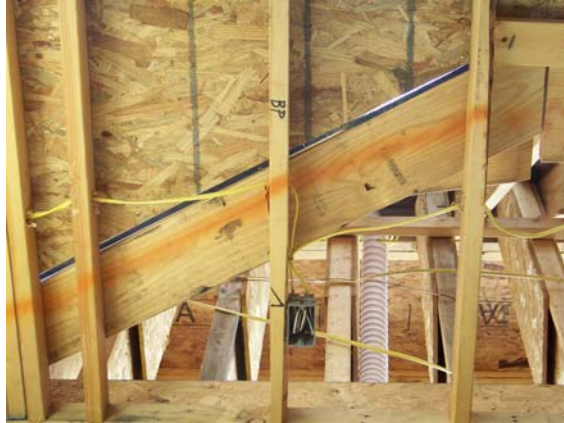
The double beam over the master shower needs additional vertical stud support at both ends. Several studs in the master bath sink wall are warped. The wall will not be straight unless these studs are repositioned or replaced.

Framing is not complete around the front garage window.

Fire blocking in the exterior wall at the garage on the second floor is not completed.

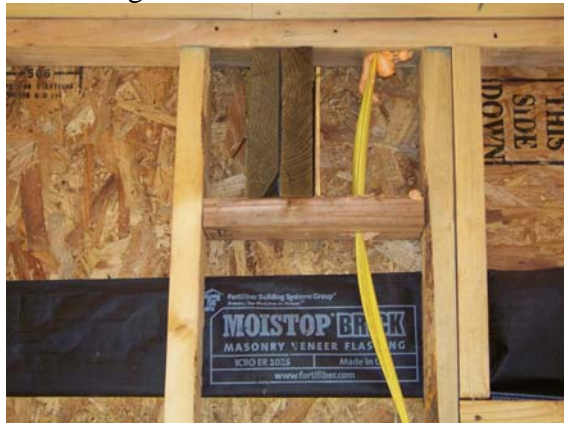
No enclosure was built around the exhaust stacks from the water heaters as they enter the second floor bedroom and closet.

The double support beams from the upper balcony have no vertical support where they intersect the exterior wall of the game room.

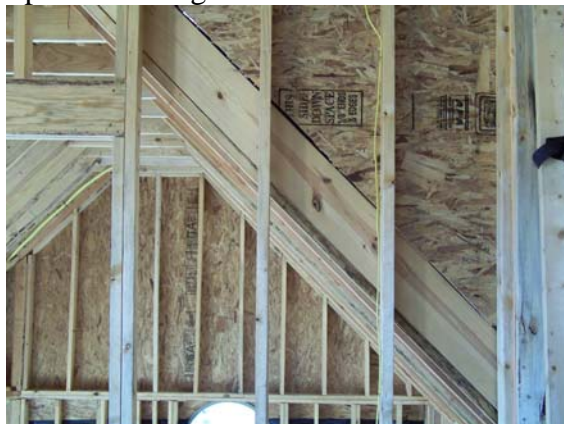
Fire blocking is not completed in the game room wall that overlooks the family room.

NOTE: Fire blocking should be done in compliance with IRC (R602.8) code guidelines.

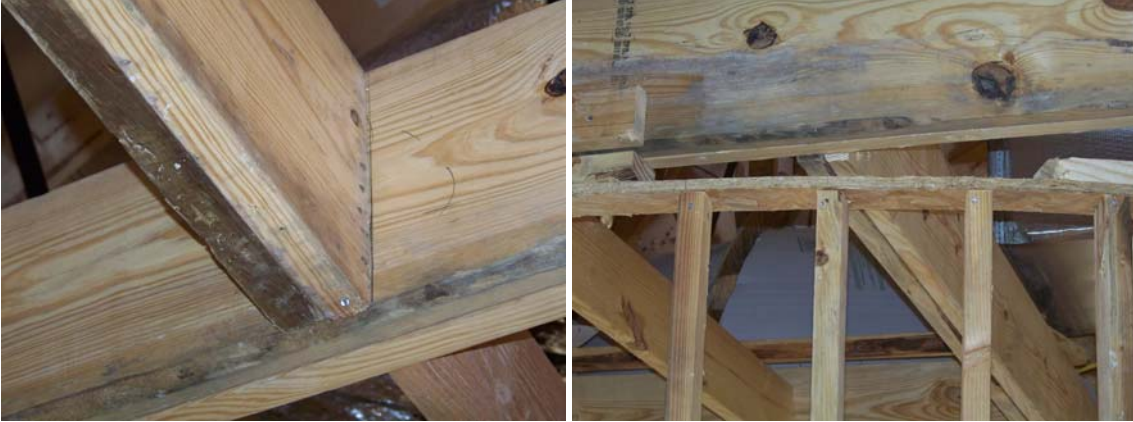
The main support beam over the entrance into the media room needs a hanger where the beam connects to the beam running lengthwise in the room. The top plate of the curved wall in the media room is missing.

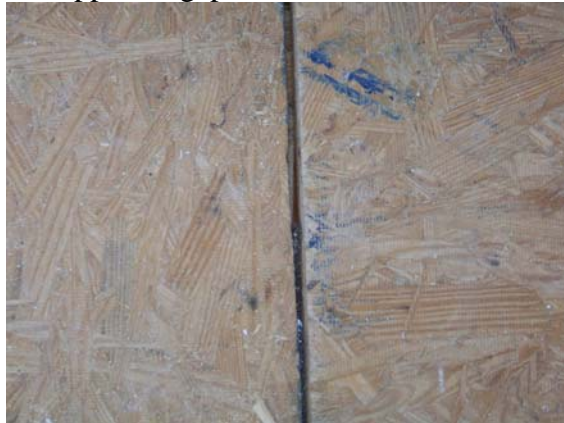
Studs are missing in the wall at the left side stairway. Floor decking in the upstairs left side hallway has large un-supported gaps that should be blocked and secured.

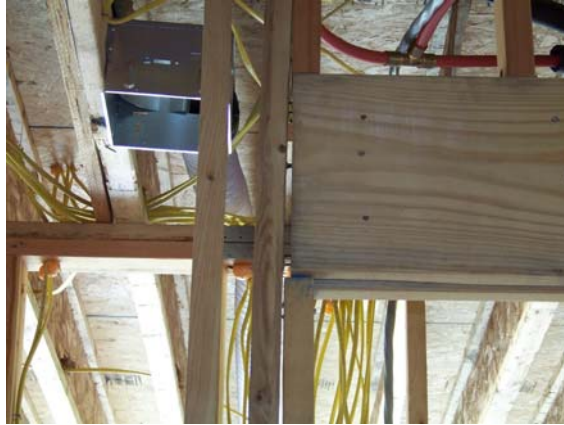
The boxed ceiling feature in the center of the kitchen is not properly secured to the TJI joists. Inspector recommends wire straps be installed from the main frame to the joists to prevent movement.

The header and support studs for the header at the doorway to the half bath are separating. The studs should be secured together and blocked to prevent movement.

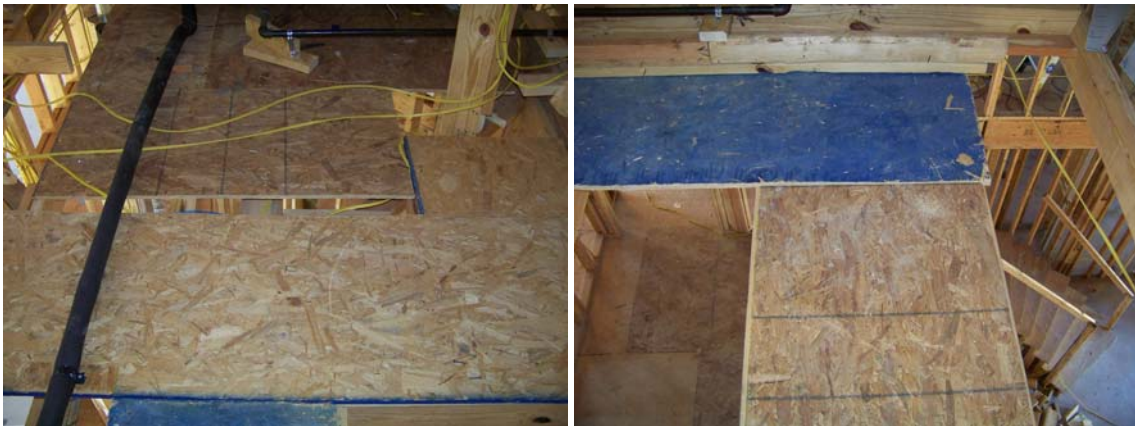
The walk surface decking in the attic that leads to the heating units is made of 7/16 inch OSB in some areas. The walkway to the unit in the center of the attic is very dangerous due to small sections of OSB used on the standard ceiling joists.

All decking used as walk or work surface in the attic should be a minimum of 3/4 inch thick. The 7/16 inch OSB is used often, but is either doubled or has additional frame support installed. The decking should be solid (no gaps between pieces) from the attic opening to both of the units. A minimum width of 24 inches for walkways and a work surface width of 30 inches in front of the units should be maintained.

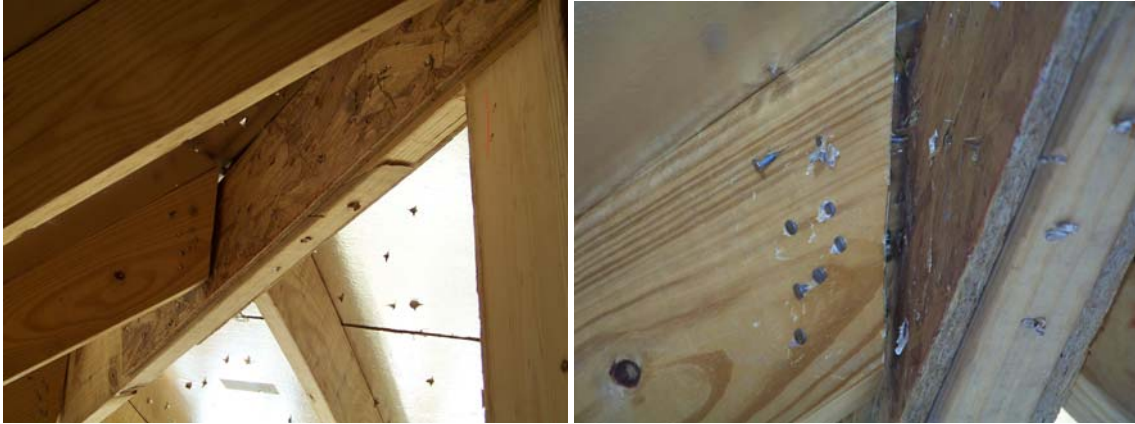
The ridge rafter on the left side of the house that terminates at the front corner has a splice that has no direct vertical support. The jack rafters are pulling away from this rafter near the splice area.

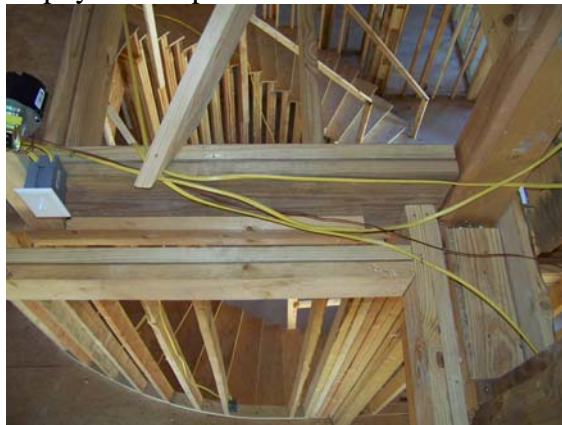
There can be no romex wiring run over the framing within six feet of the attic entrance that is not protected from physical impact.

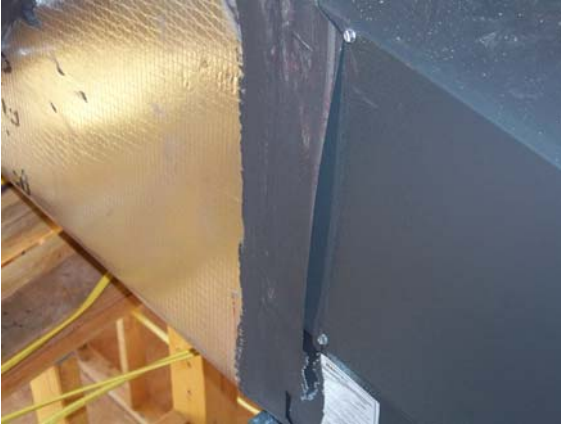
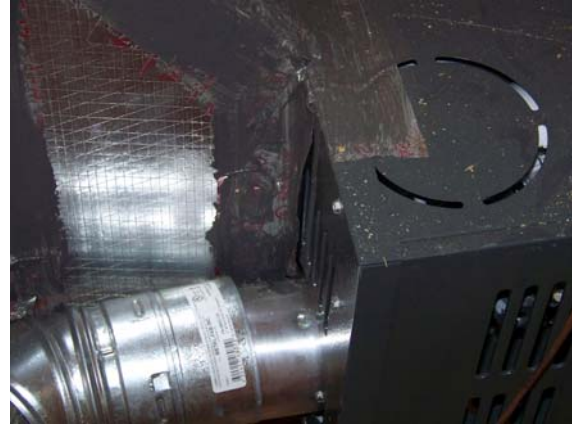
Both units in the attic have loose tape on the plenums and the connections to the evaporator coil enclosures. These seams should be taped and hard cast after the unit and plenum are stabilized.
