PRE DRYWALL INSPECTION REPORT

Concerning: DELETED, San Antonio, TX 78258
(Address of Inspected Property)

By: Kevin Machen, # 5043 10/08/08
(Name and License Number of Inspector) (Date)

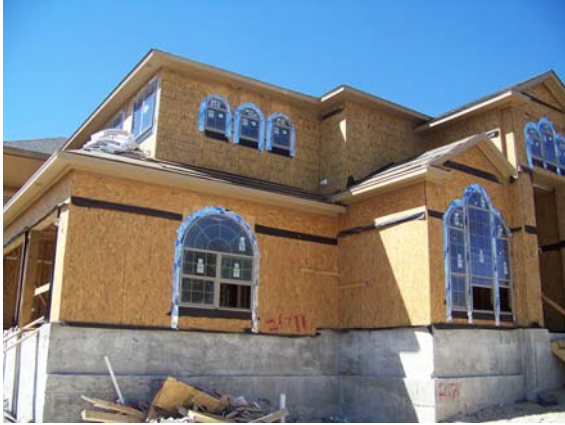
Front exterior

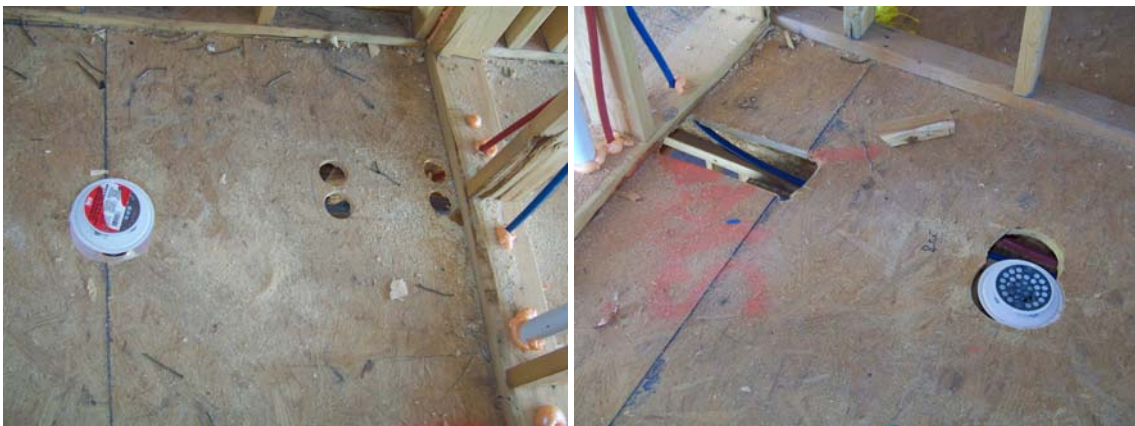
Fireblocking should be in the following locations:

- 1. In concealed spaces in stud walls and partitions, including furred spaces and parallel rows of studs or staggered studs as follows: Vertically at floor and ceiling levels and horizontally at intervals not exceeding 10 feet.**
- 2. At all intersections between concealed vertical and horizontal spacings such as occur at soffits, drop ceilings, and cove ceilings.**
- 3. In concealed spaces between stair stringers at the top and bottom of the run.**

4. At openings around vent pipes and ducts at ceiling and floor level. (compressed fiberglass or approved spray foam)

All perforations in the top plates of the walls (plumbing lines, drain lines, electrical wiring, etc.) should be sealed with an approved fire retardant material.
