ADDRESS DELETED

SAN ANTONIO, TX 78219

This inspection consists of several buildings located at the same address. The space consists of office space, storage, and commercial work space.

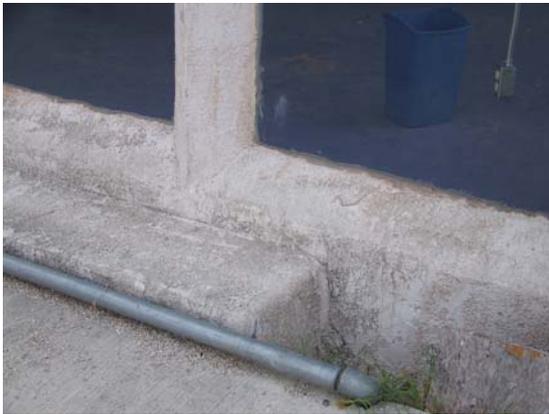
The stucco apron that begins at the base of the windows has a grade that is above the floor level of the interior of the building. Inspector is not able to determine the type of “drain plane” used to prevent water penetration under the window and wall framing along the entire length of the stucco veneer.

Apron above floor grade level

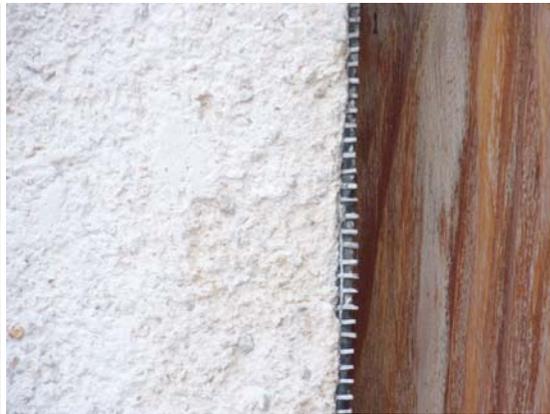
The exposed fiberglass mat located at the edges of the window and around the door frame indicates that the stucco was not properly terminated. The exposed wood framing around the door will continue to deteriorate unless properly sealed. The wood doors also have no provisions for prevention of water penetration along the top and sides. Negative drainage at the base of the door also promotes water penetration to the interior of the building.

Exposed fiberglass matt backing material

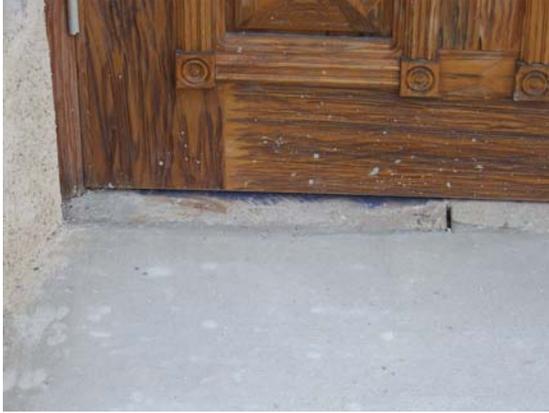
Negative drainage at door threshold

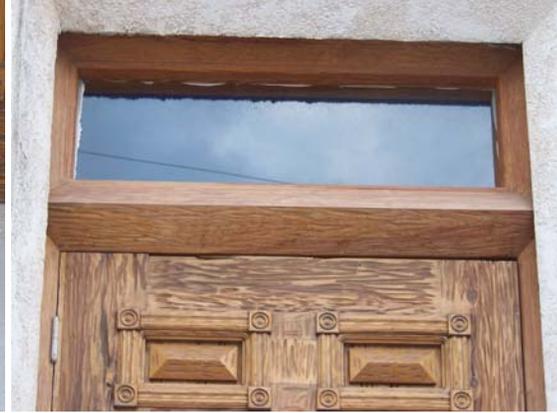
No flashing or seal around top of door frame

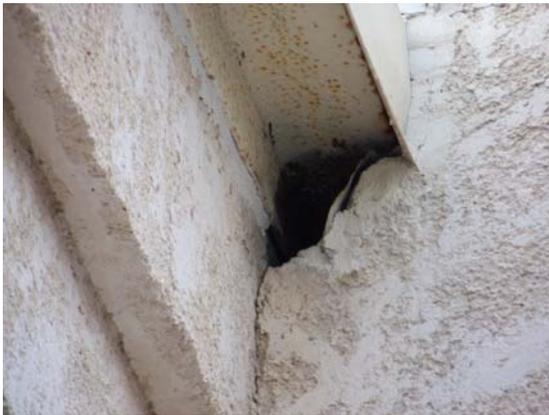
Voids in the stucco coating on the sides of the column features where the roof intersects, have lead to water penetration and excessive mildew development in the stucco. Openings in the top edge of the stucco below the steel roof framing should be sealed to prevent water penetration to the back of the stucco covering.

Voids in stucco at roof/column

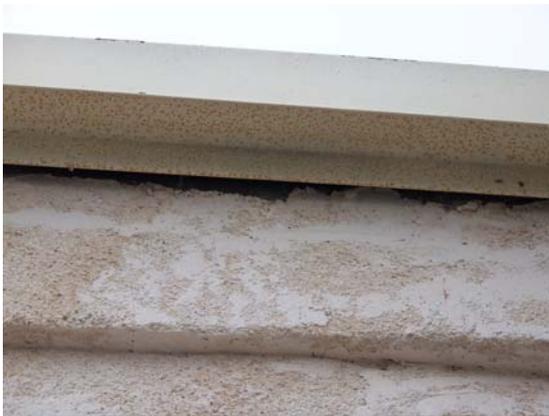
Voids at stucco and roof flashing

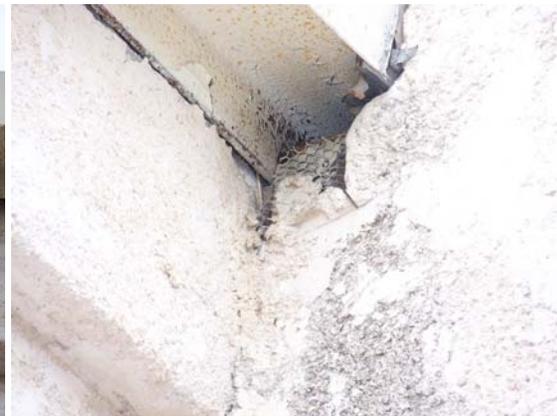
Void in stucco at roof/column

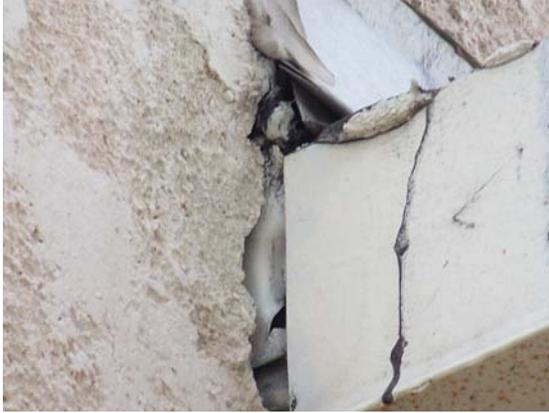
Flashing not sealed on side of column

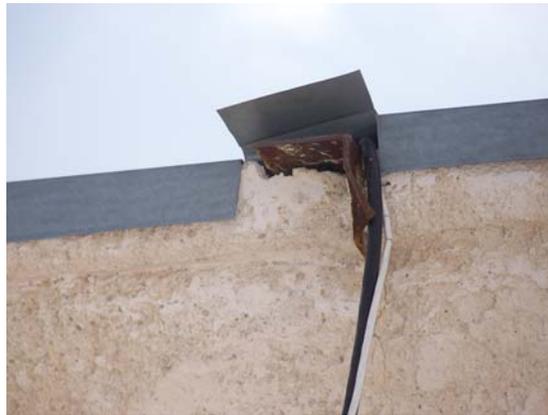
Steel bracket protruding from column

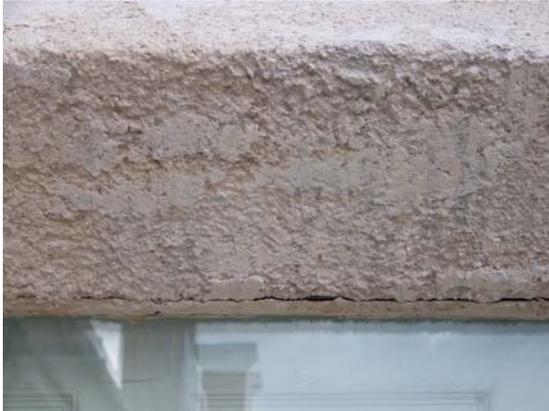
Crack along window frame edging

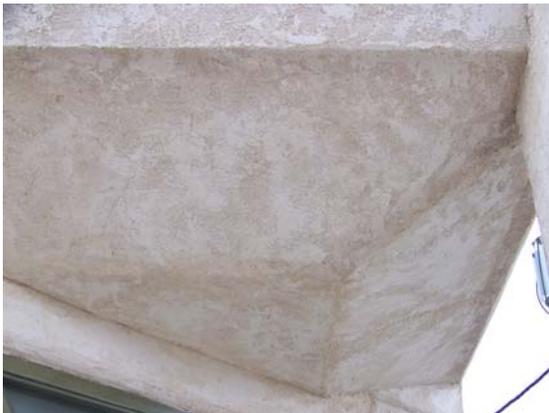
Front door ceiling on exterior

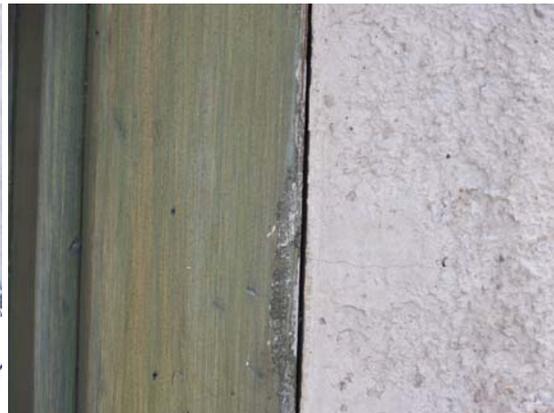
Door frame not sealed to stucco

The edges of the door frame and trim should also be sealed to the stucco to prevent water penetration.

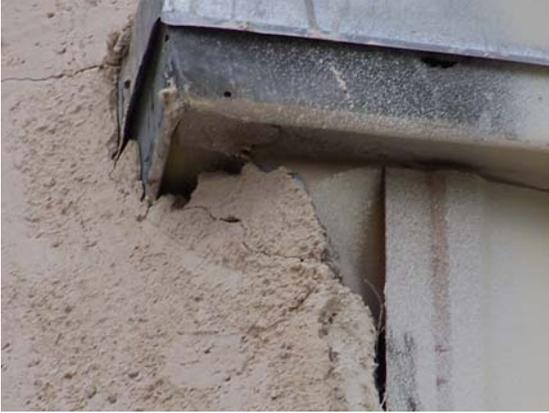
Exposed steel framing on the right side that is not sealed to prevent water entering the building wall cavity

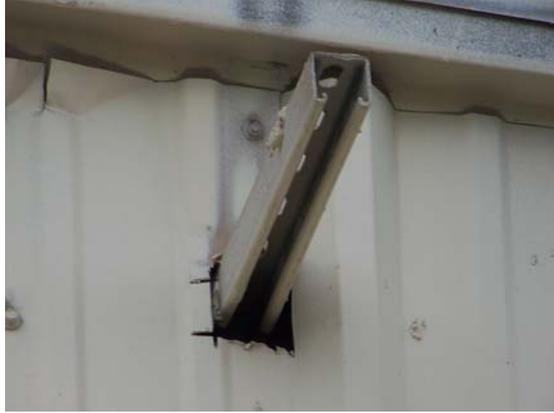
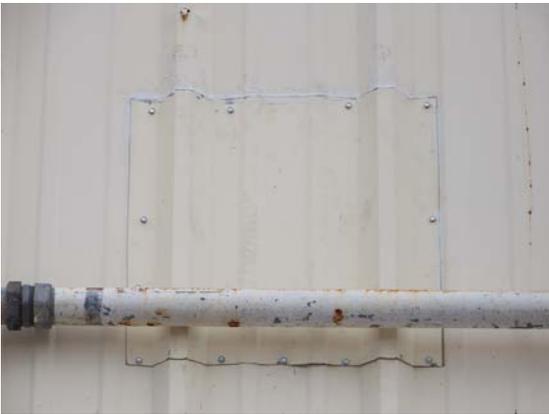
Patch on metal relying on sealant for waterproofing

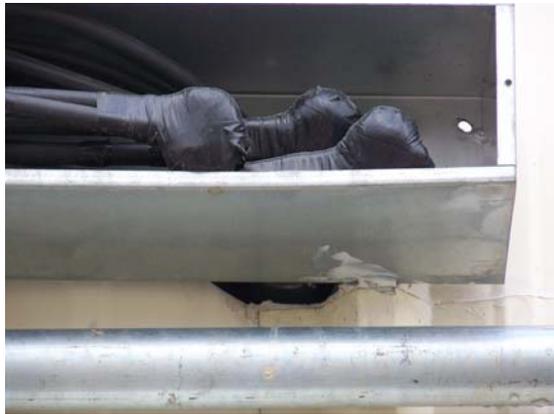
Open electrical junction and wall penetration

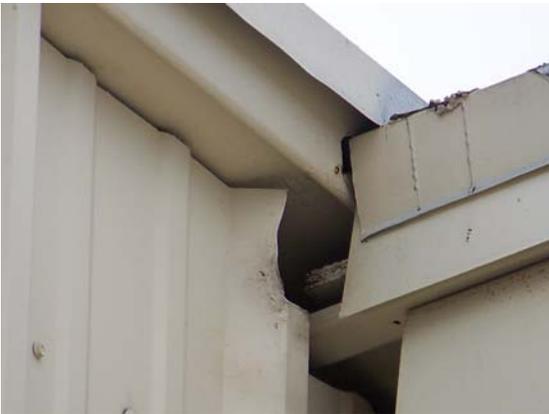
Open area in metal around framing

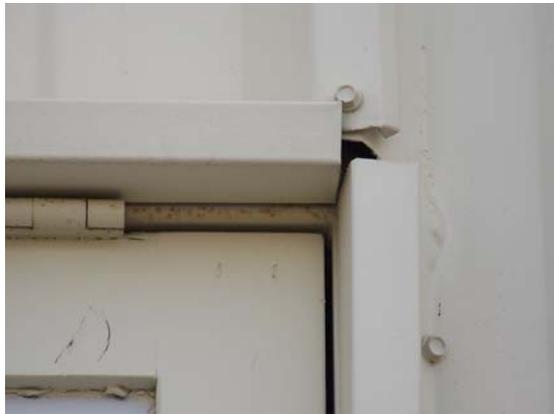
Window not properly flashed

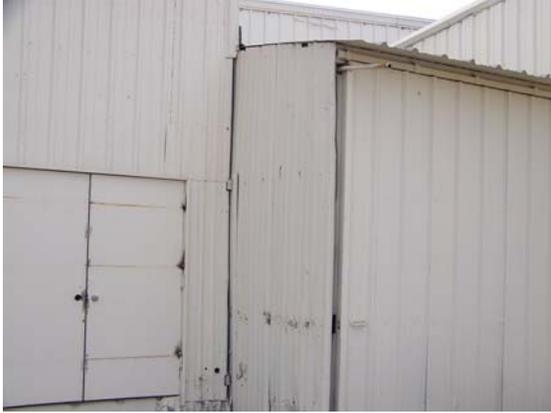
Wall open at corner to building

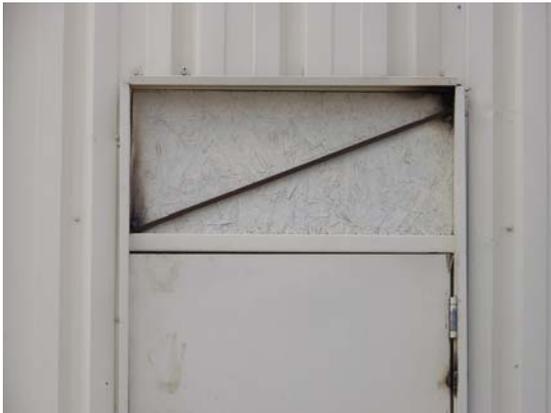
The front roof edge cover over the large store room that extends to the right side fence is rusted out. The OSB panel used to fill the cavity above the entry door to this area is not stopping water penetration. The door and steel framing below this location both have water related damage.

OSB sheathing used above door

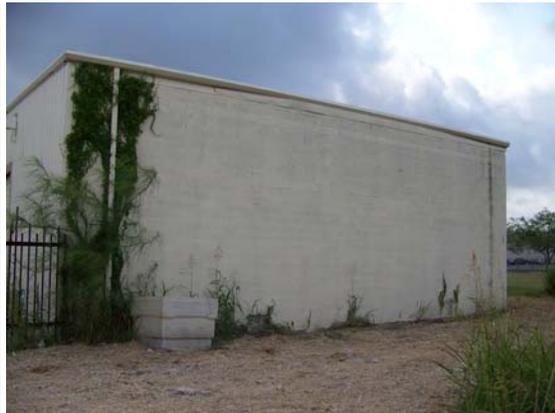
This CMU wall has several settlement cracks. The metal flashing that is placed immediately below the edge of the roof is loose and should be secured.

CMU wall with settlement

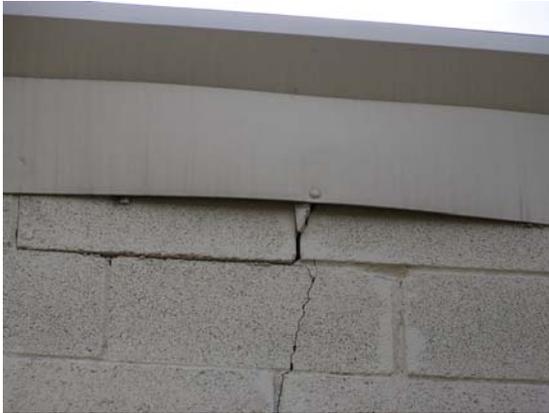
Loose wall trim at top of wall

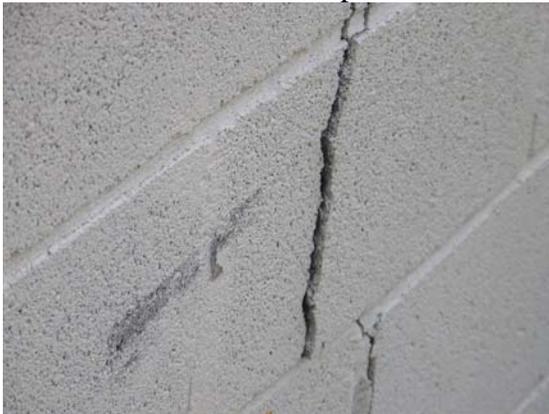
The separation of the blocks at the angled corner at the back edge of the building is wider than in other places. There is a small amount of horizontal deflection between the sides of the cracks on the lower back side that indicates some structural movement of the lower wall. This may be caused by the water pooling inside and outside this wall during heavy rain periods.

Horizontal displacement in cracks in wall face and corner of building

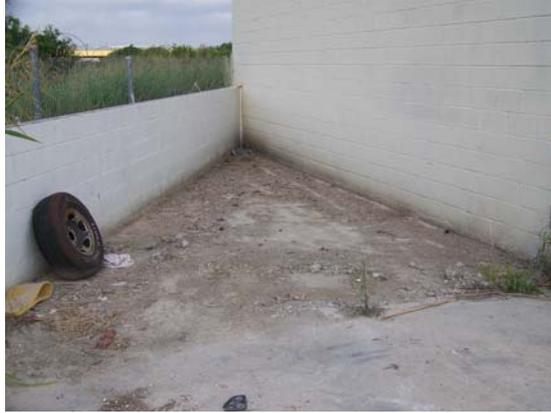
The back storage area has a large gutter dumping into a concrete “trough” at the corner of the garage and warehouse, with no additional drainage present. Water marks on the foundation and metal indicates that the water reaches a level high enough to enter the building during heavy downpours.

Area at fence and back of garage that traps water during heavy downpours

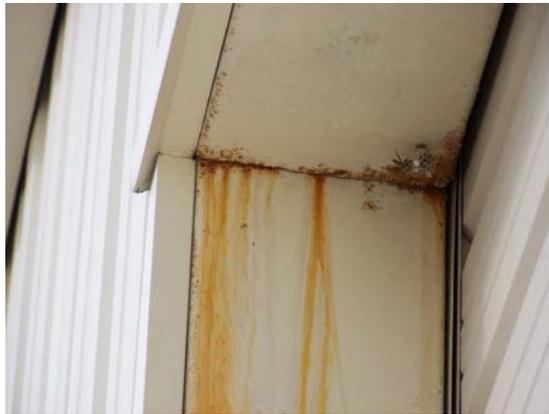
Rust streaks coming from above the overhead door framing are from water penetration at the roof level. Patches in the wall metal and un-sealed perforations need to be properly repaired and sealed.

Water penetration at top of overhead garage door framing

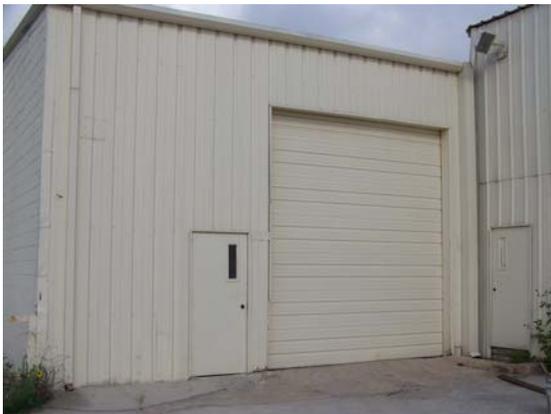
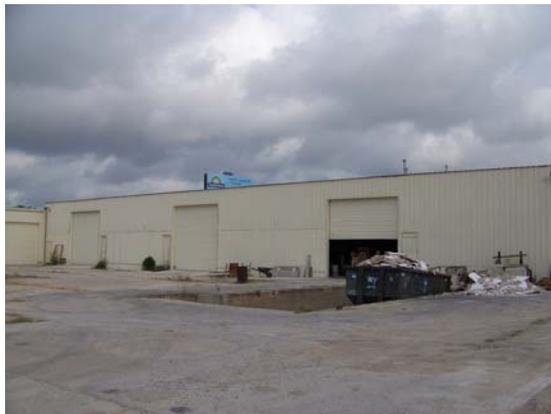
Back entrance doors to garage and warehouse area

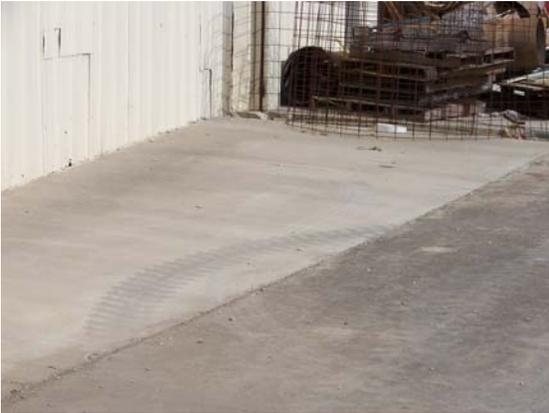
Concrete skirting used to prevent water from pooling at the base of the wall and entering building

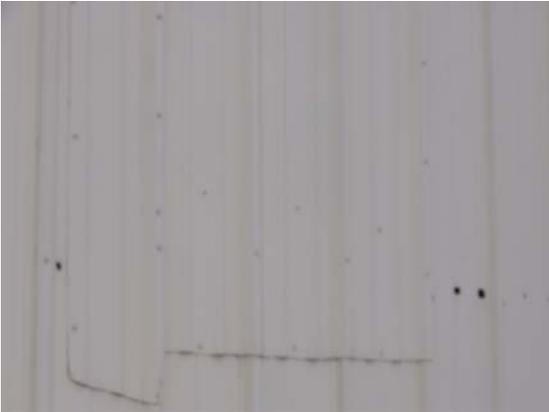
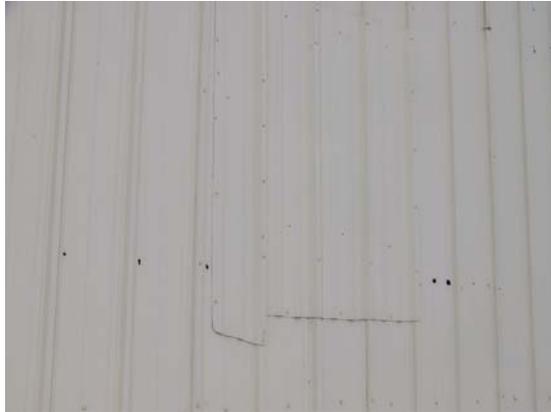
The back section of the building on the left side has numerous perforations due to corrosion and physical damage that should be properly repaired.

Large patches on left side not properly installed

Replacement of some of the metal may be required due to the extent of the damage and the number of patches that are not properly installed on the exterior wall.

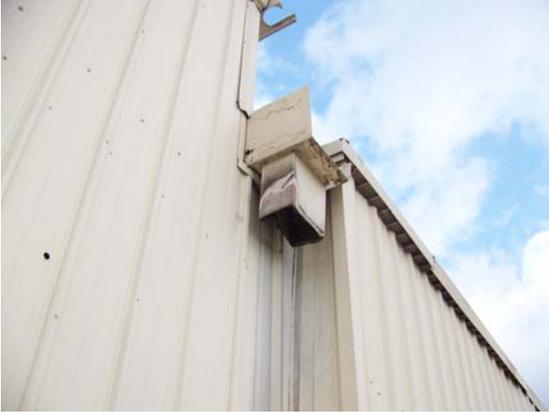
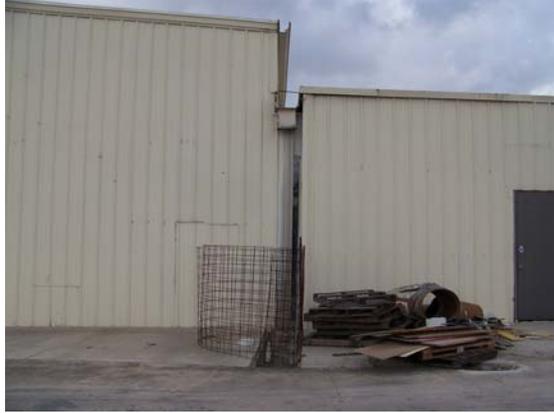
Large gutter termination between front building and warehouse

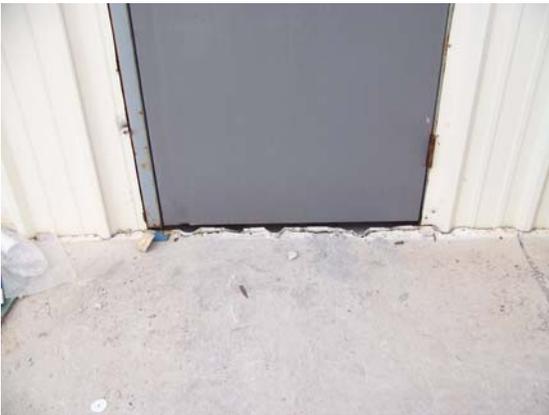
Opening to the lower floor at base of door

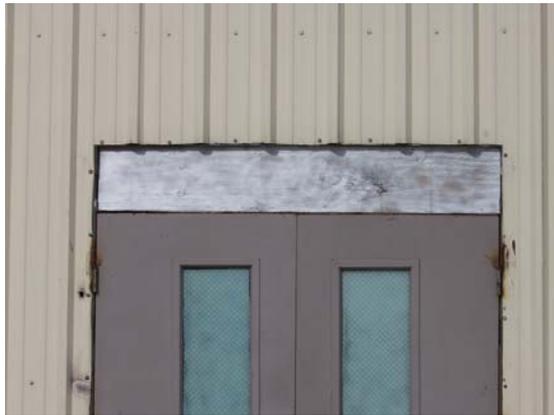
The wood panels over the double door set on the left side do not prevent water penetration during rain periods. These should be replaced with metal or glass to prevent additional water damage to the steel framing.

Wood over double doors

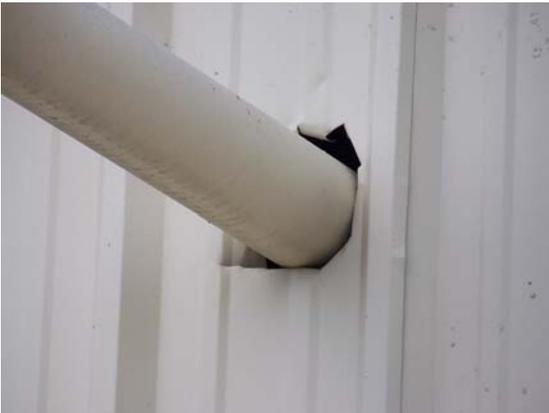
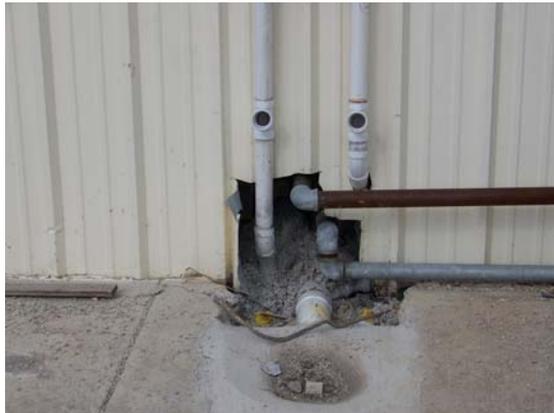
Perforations and open holes in the building wall for piping

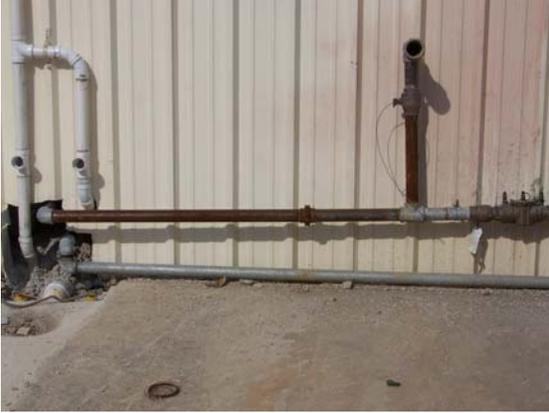
Two water lines that run along the left side wall near the front fence need to have additional bracing to prevent damage from physical impact.

Water lines that need additional bracing

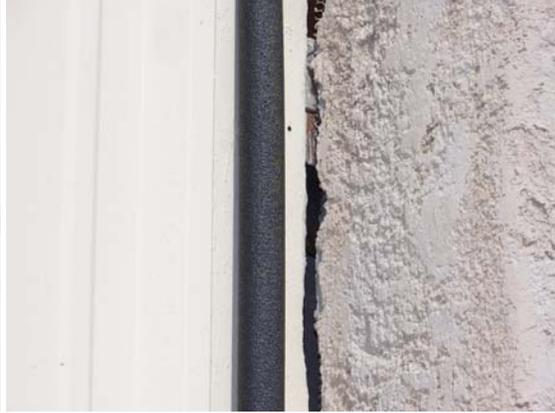
Seam at metal and stucco on left side

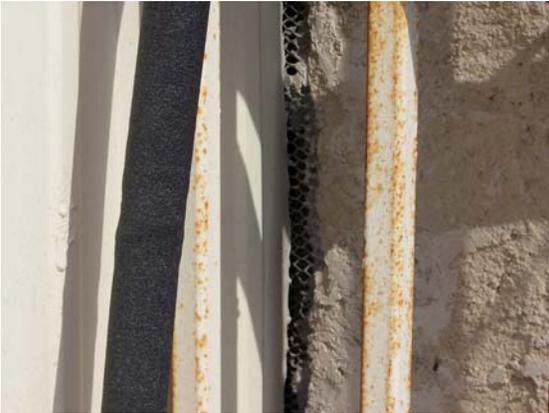
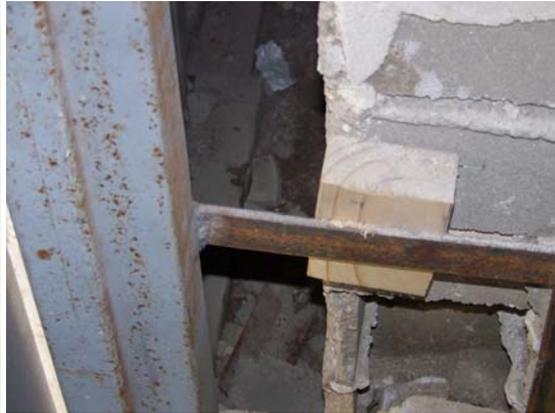
Open seams in exterior metal and exposed inner wall cavity

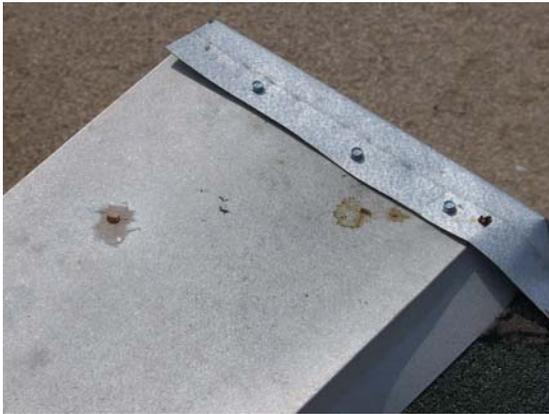
This tar and gravel roof appears to have a 2:12 pitch that empties to the right side of the building (when facing the building from the street). Except for the end cap located at the back left corner, all metal caps on the parapet roof walls appear to be properly sealed. Aggregate distribution over the entire roof area is uniform, with only a few areas around the edges with exposed tar and underlayment. No areas of ponding water were noted.

Metal cap trim not properly sealed

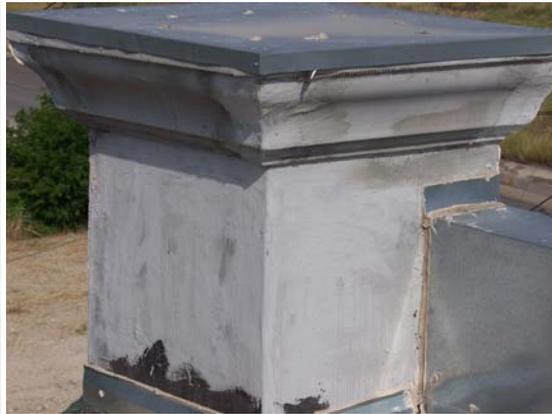
Stucco finish is not completed on back of column

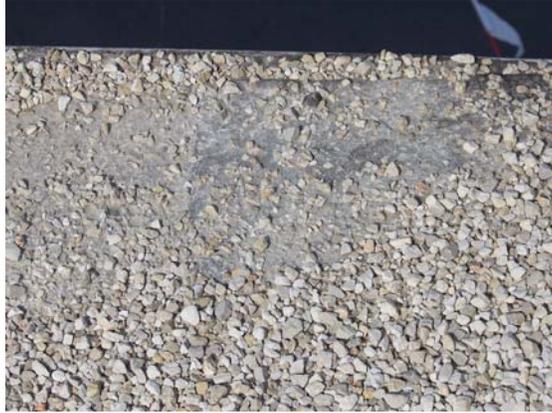
Small area of exposed tar and underlayment

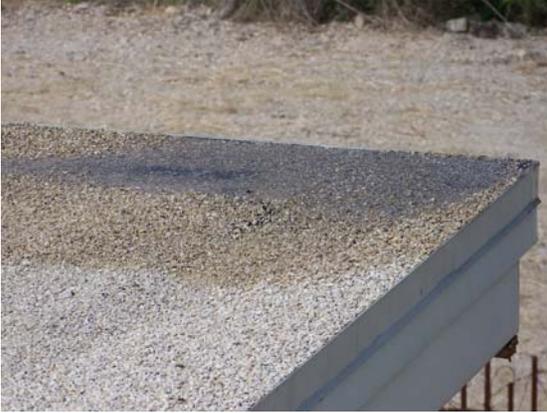
Water ponding at roof edge

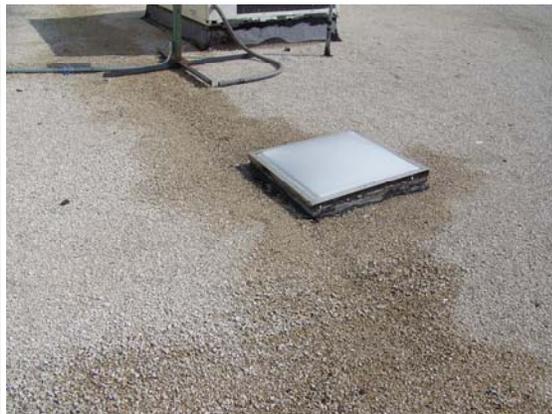
Water ponding around skylight opening

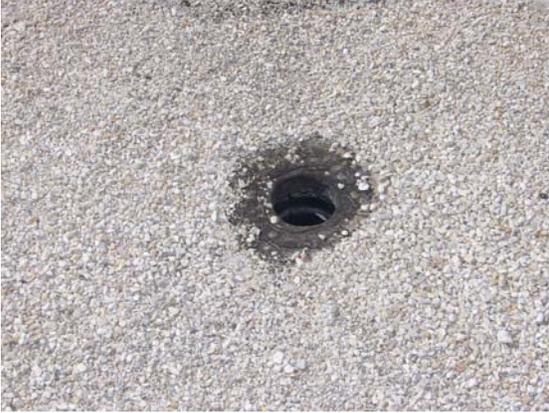
Drain opening with no cover

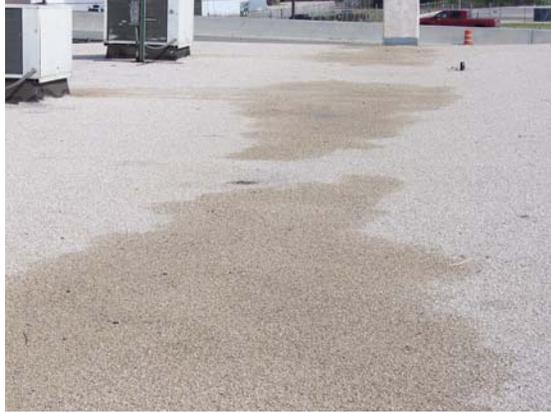
Water ponding in between drain openings

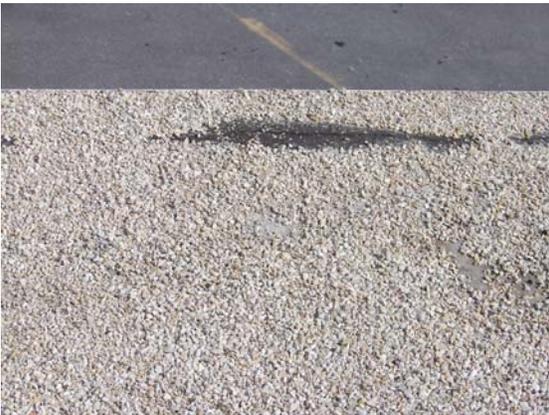
Bare tar/fiber at roof edge

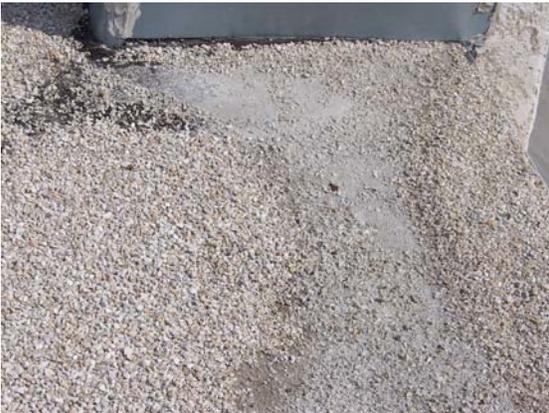
Missing aggregate around corner column

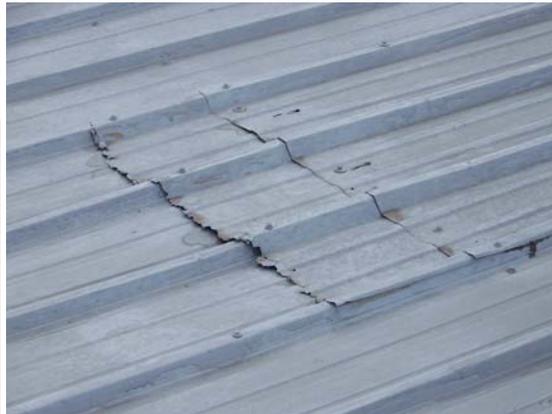
The metal roof on this building has approximately 1:12 pitch, which is adequate for the roof covering. Several small patches were noted on the side adjoining the showroom and office. Large areas at the ridge that are covered in flat material are most likely vent covers. It appears that the original vents positioned in the roof have been removed.

Small patch area

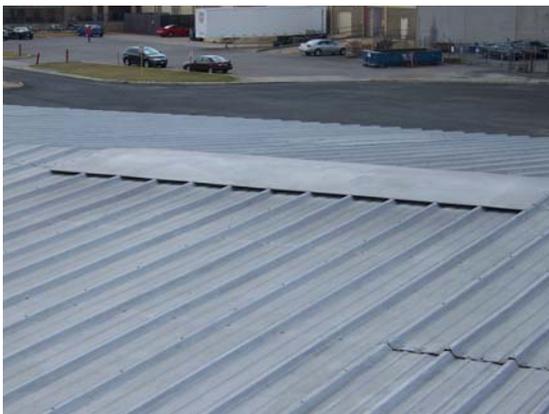
Flat panel over ridge vent area

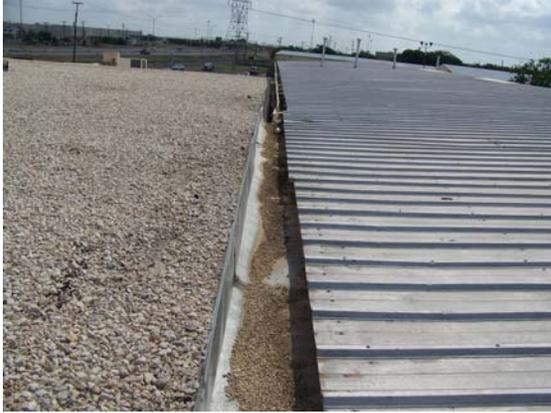
The back side of this roof empties into a large gutter that carries the water to the east end of the building. This gutter runs the full length of the buildings from west to east. There are several areas where the metal used to make the gutter has come apart and needs to be repaired.

Gutter area showing debris at bottom

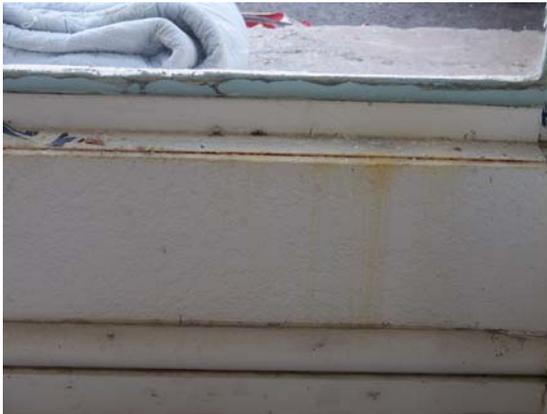
Signs of water penetration were noted along the base of the windows along the front of the lobby area.

Streaks indicating water penetration around the window seals

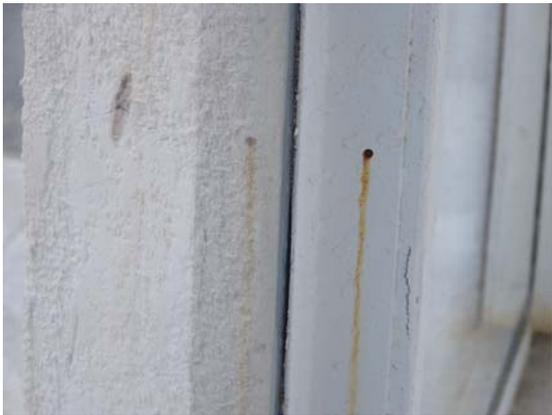
Water penetration on the sides of the window frames

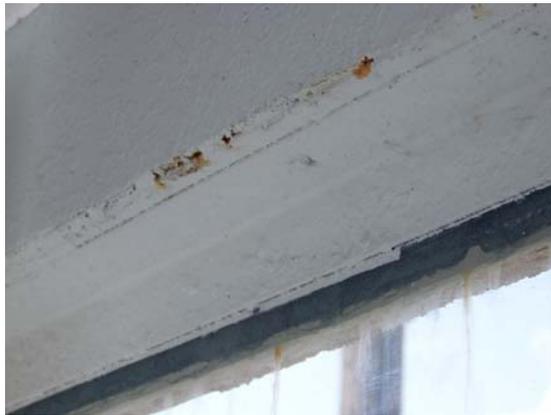
Signs of water penetration on the upper windows

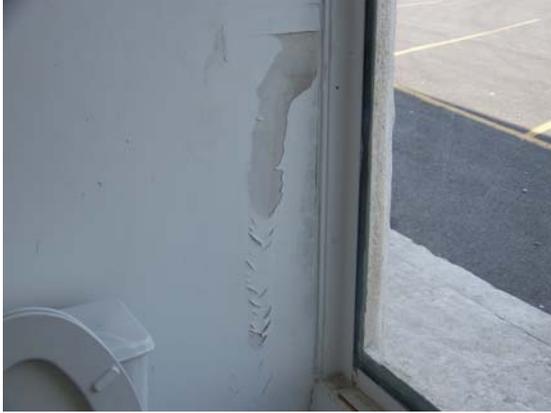
Loose paint from moisture in bathroom wall

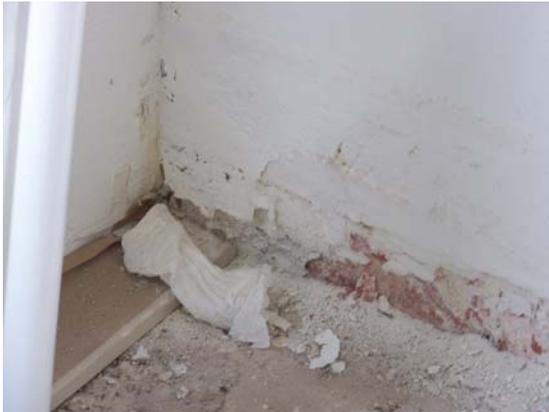
Moisture related delamination of the drywall on the bar wall at the front corner also indicates water penetration at the slab level.

Deteriorated drywall at the front wall where the bar meets the showroom

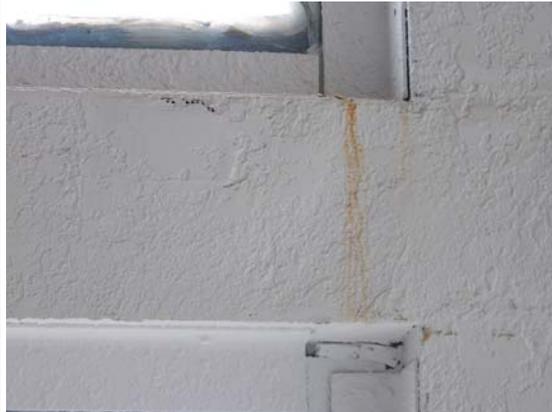
Leak around frame of upper level window

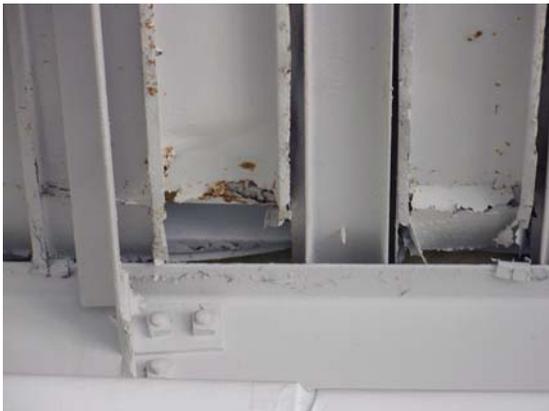
Two-by-fours and other pieces of wood were driven between the structural beams and the roof decking material to help support areas that were rusted out due to long term leaking of the roof at this location. There were some areas of the metal decking system that were badly rusted, and had no additional support.

Rusted purlin braces under roof decking material

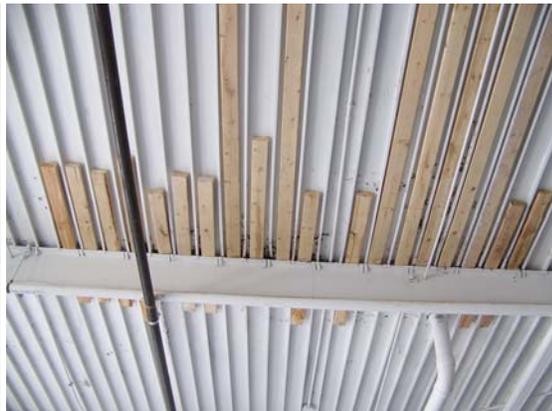
Two-by-four bracing under roof decking

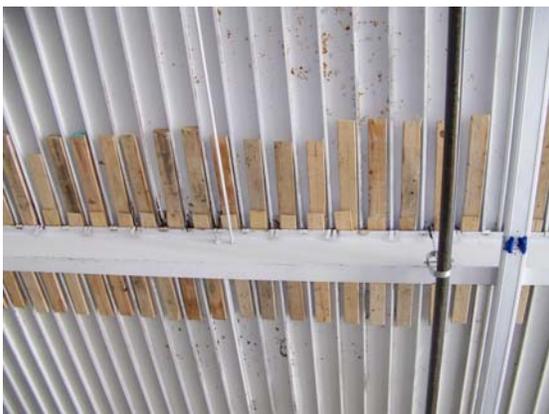
Wood bracing under roof decking

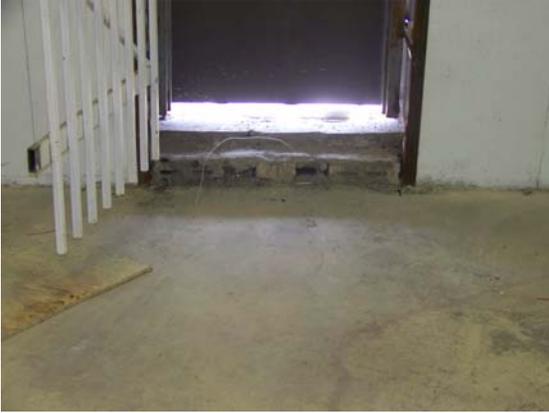
The single exit door on the back left side wall that connects to the show room has no threshold seal to prevent water penetration. Openings on both sides of the door indicate two separate walls (original load bearing CMU) and metal coverings. Low area between the two wall coverings will pond water during prolonged rain periods. Whether the low area will fill and afterwards enter the building could not be determined at the time of inspection. Examination of the staining in the walls and floors indicates water has entered the building in this manner at some time in the past.

Left side door with no seal at threshold  
(Note lower level of floor in room)

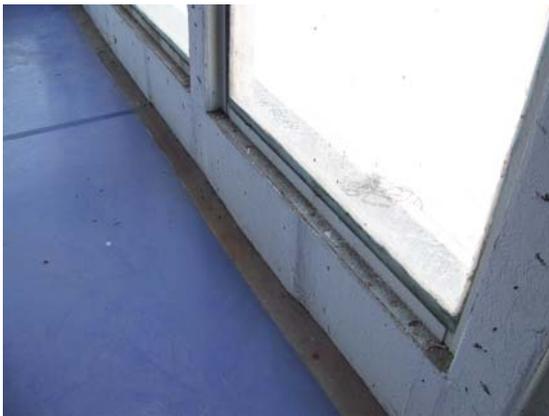
Photo showing higher grade on exterior wall

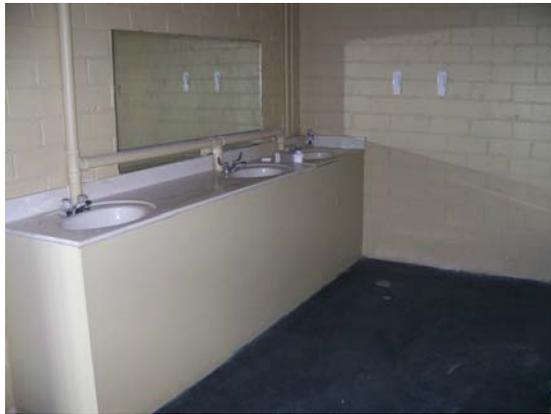
Men's restroom facilities

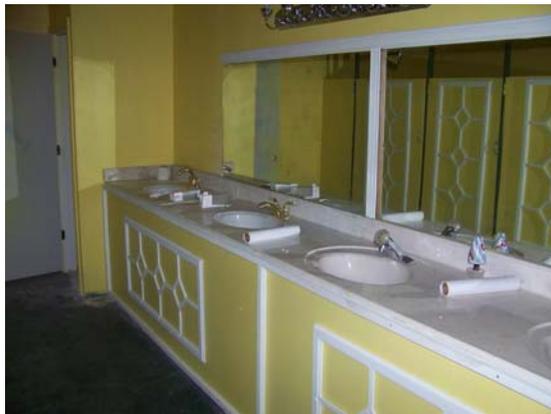
Ladies restroom facilities

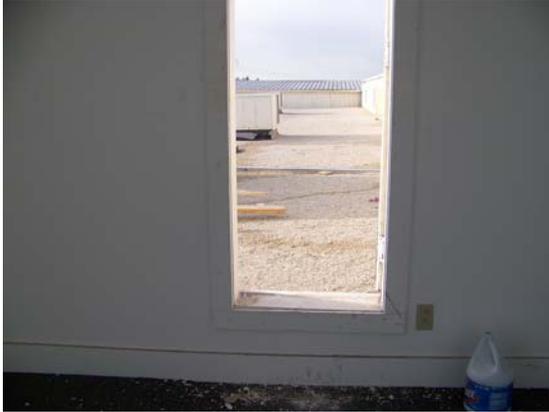
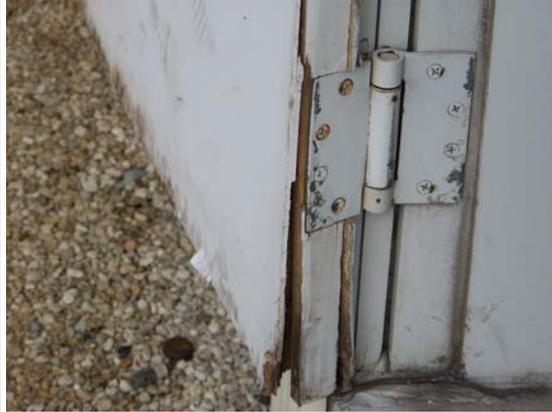
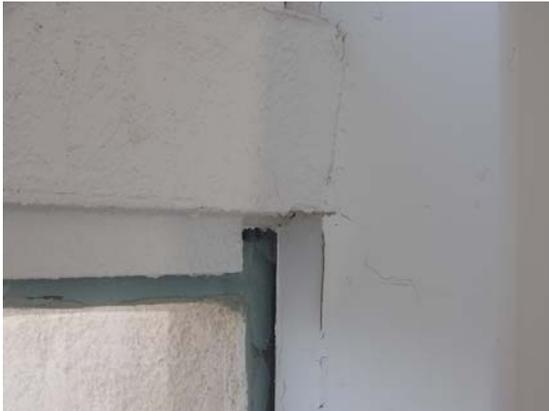
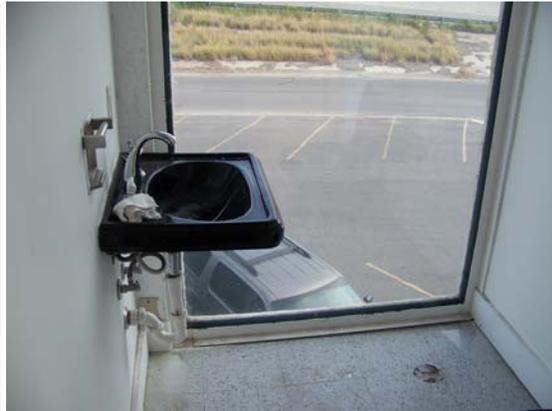
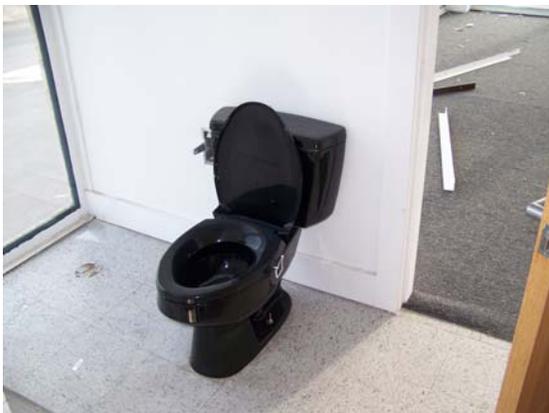
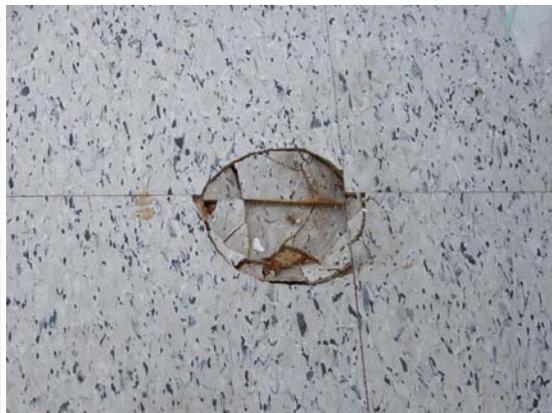
## CONFERENCE ROOM:

The front glass panel that was broken has been replaced. The windows appear to be surface sealed only. Signs of water penetration from the windows or roof were noted at the back left corner where the wall and windows meet. The exit door to the roof should be weather stripped on all sides to prevent water penetration during blown rain. The door has delaminated due to exposure and should be replaced. The lights and power functioned properly.

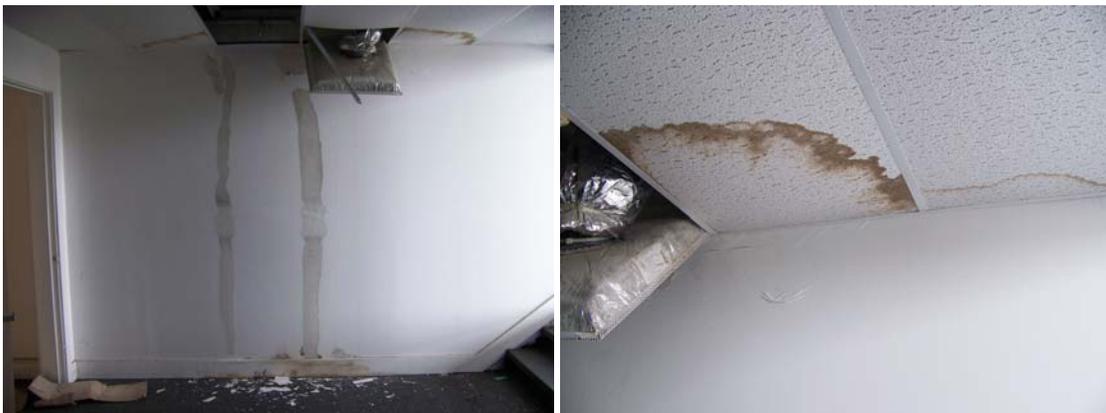
### **TELEPHONE ROOM:**

Signs of water penetration were noted in the exterior wall and ceiling. This is from a roof leak that may have been recently repaired. No insulation was noted in the ceiling cavity.

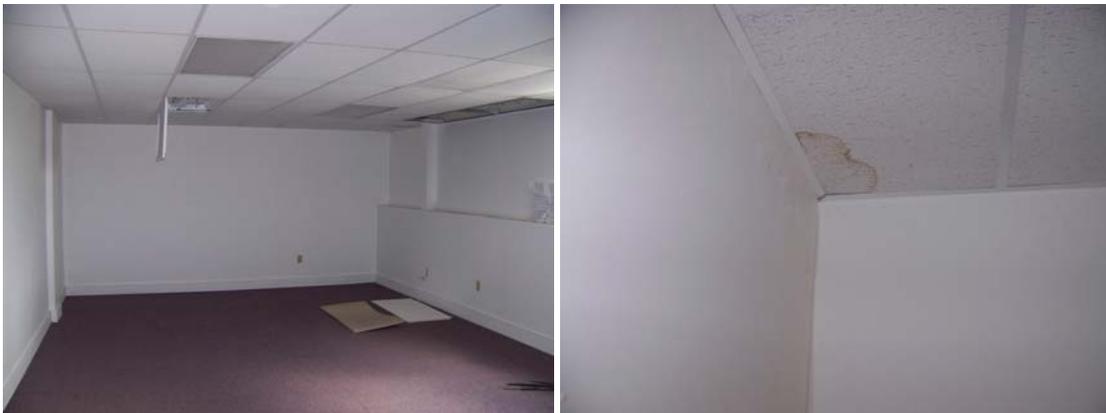
**SE2:**

Water stains in the ceiling from a roof leak were noted in the back corner of the exterior wall. Water penetration from around the window with minor damage was also noted. The lights and plugs were operable.

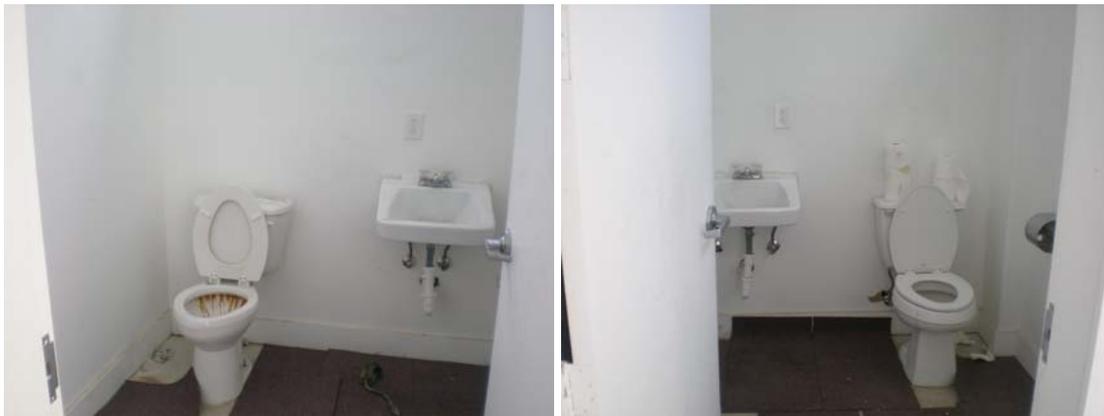
## **BATHROOMS (On the right side office area, lower level):**

The left side bath toilet and sink are both loose and should be properly secured. The lights and plugs are operable.

Both entry doors need adjustment to latch properly in the door frames.

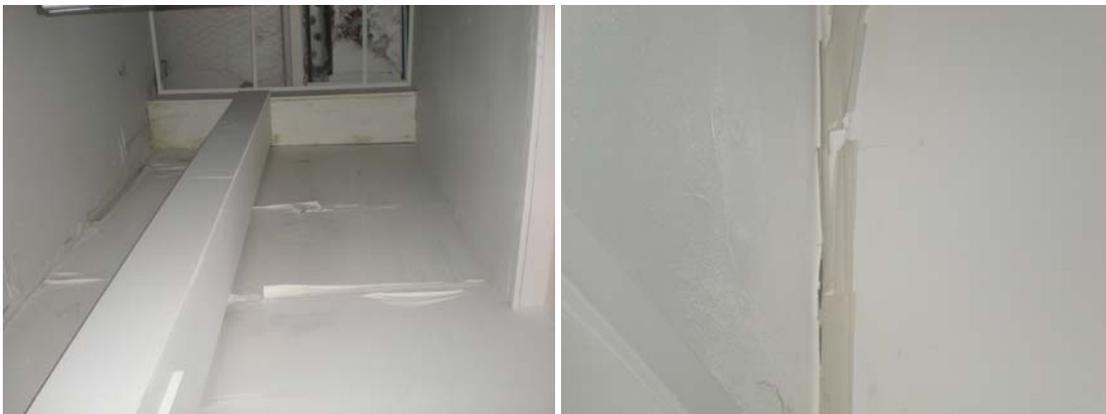
The drywall in the stairwell has water damage from the roof and gutter leaking in this area. The bottom of the gutter itself has stains and rust from condensation or leakage.

Moisture damage in the drywall seams

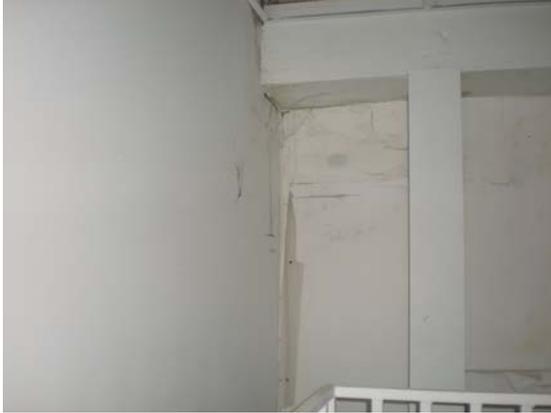
Moisture damage at top corner of wall/ceiling

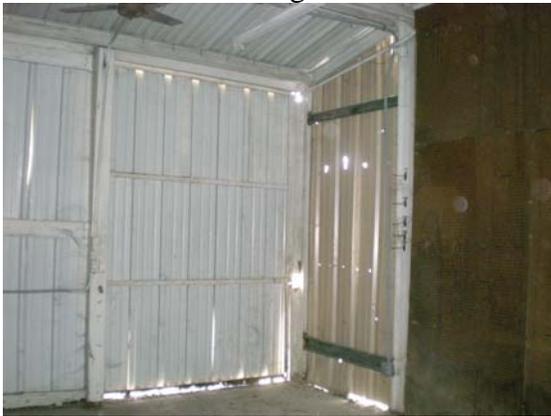
Small enclosed garage area on the front of the building

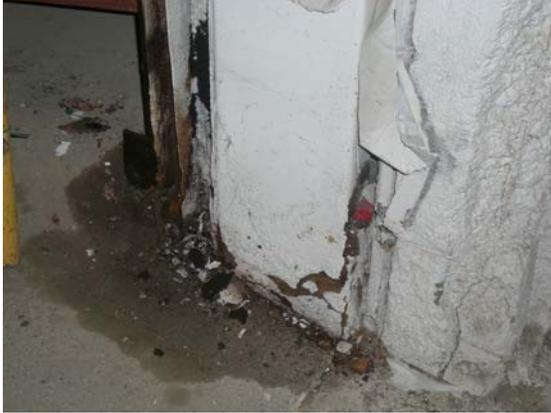
Rusted support beam at garage/warehouse  
Wall

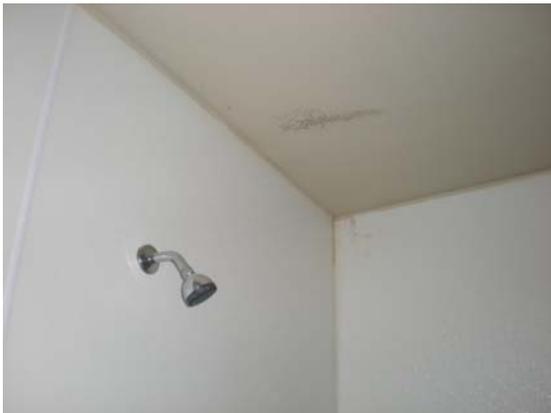
Water stains in ceiling of bathroom. Bathroom shown with partial shower pan in place.

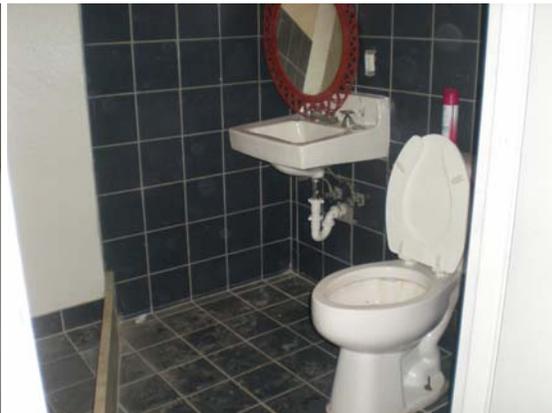
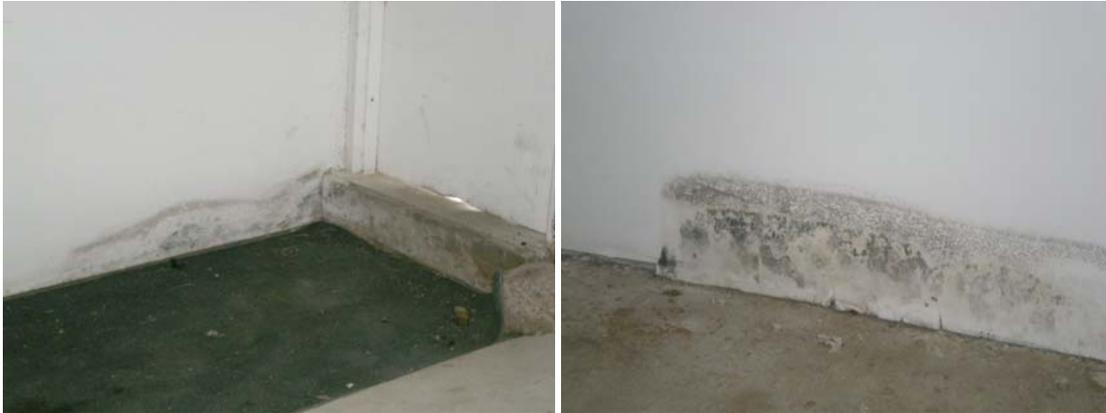
Walls of the large corner office located near the front wall of the building has fungal growth due to moisture penetration. The water appears to be entering the building from the back door and back wall where water is trapped next to the building by the perimeter fence.

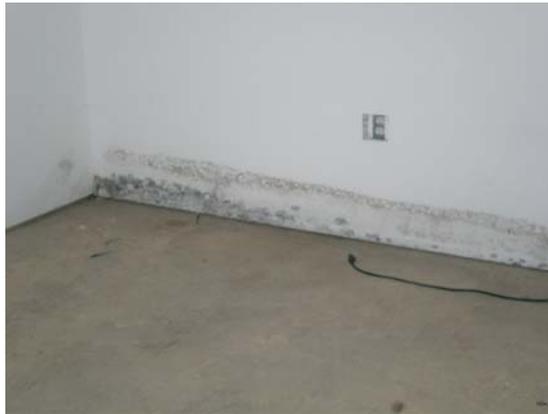
Fungal growth

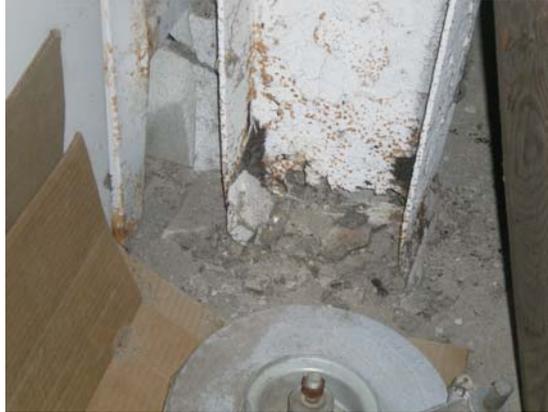
Rusted steel was present along the back walls below the gutter that runs between the warehouse and showroom building. The rust and other water damage was widespread and judging from the rusting of the main support I-beam trusses, it has been occurring for a long period of time. Of the eight points of contact with the slab from the main support structure, four of the steel I-beam sections need repair due to rusting and corrosion.

Rusted structural support beam
