ADDRESS DELETED

SAN ANTONIO, TX 78219

This inspection consists of several buildings located at the same address. The space consists of office space, storage, and commercial work space.

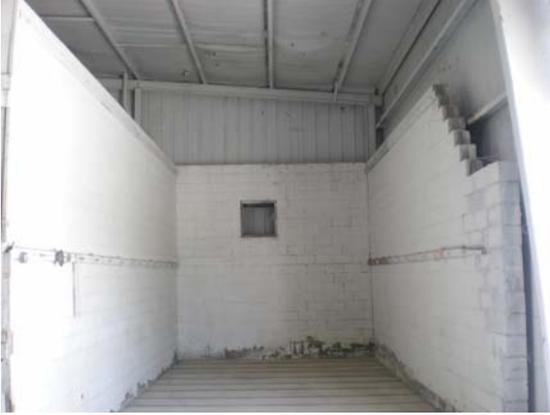
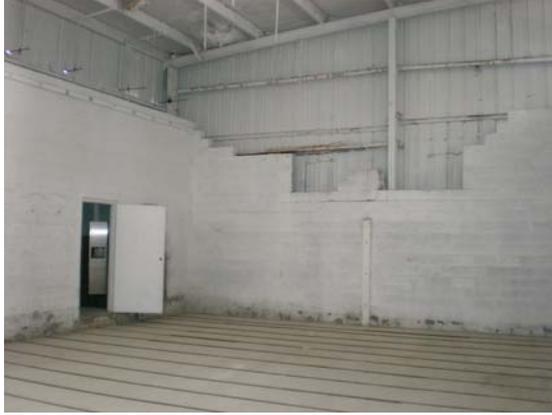
The floor of the warehouse in the back left side section appears to have deteriorated and broken up. This area has steel rebar laid out as if a new layer of concrete is about to be installed.

CMU section of building with rebar laid out on floor. Bathroom is pictured in the right side photo

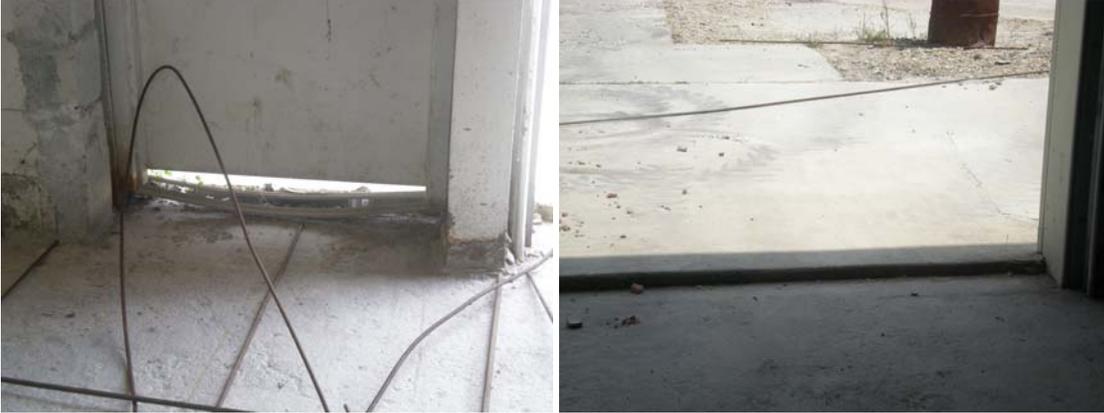
The floor level in the warehouse is below the flat work level on the exterior at the left and back sides of the building. Despite the installation of a sump pump in the recessed truck dock, there most likely will be water running into the building on the back side when heavy rains occur.

Rear exit doors showing negative drainage from the exterior

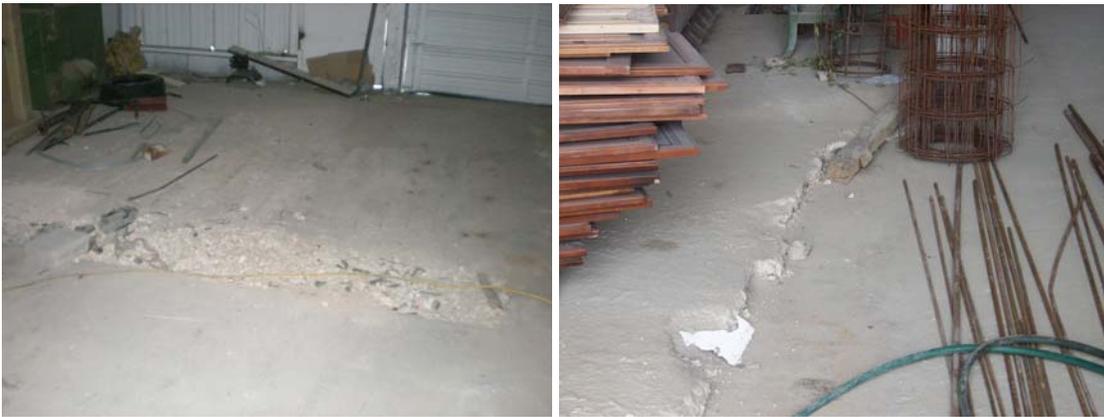
Floor of warehouse showing elevation changes due to removed floor level concrete

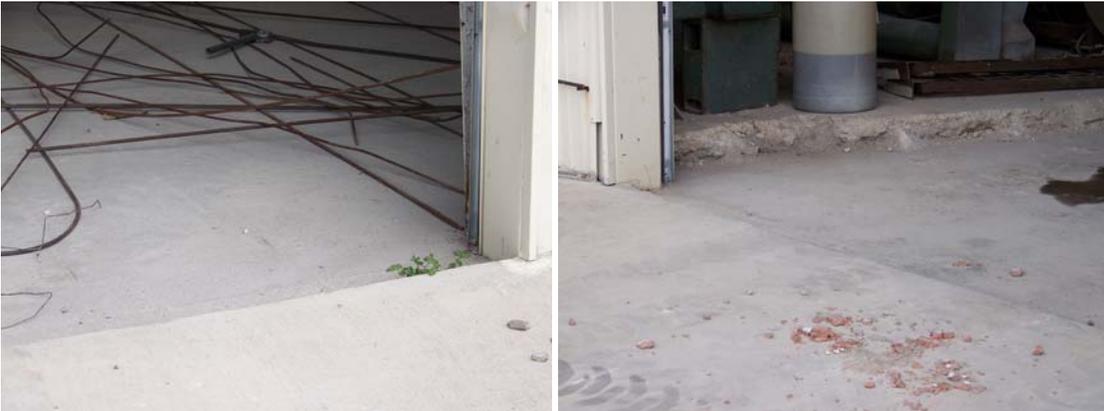
Photo from back side exterior of building showing elevation change from exterior to interior floor grade

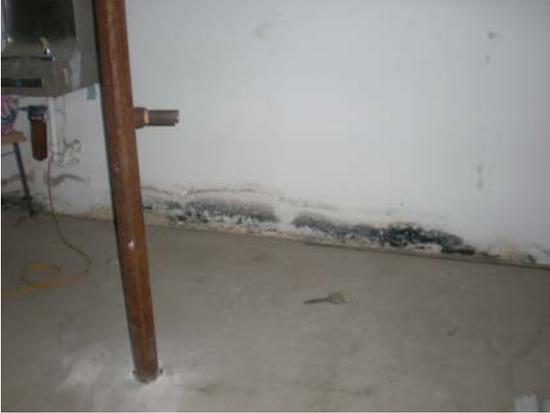
The right side wall of the warehouse has offices and bathrooms constructed. All of these rooms are badly water damaged. Damage in the upper level rooms indicate the water has been coming from the gutter area above the rooms where the warehouse and garage roof tie together. These rooms will need extensive remodeling in order to be used.

Fungal growth and water damage to top level rooms over right side bathrooms in warehouse

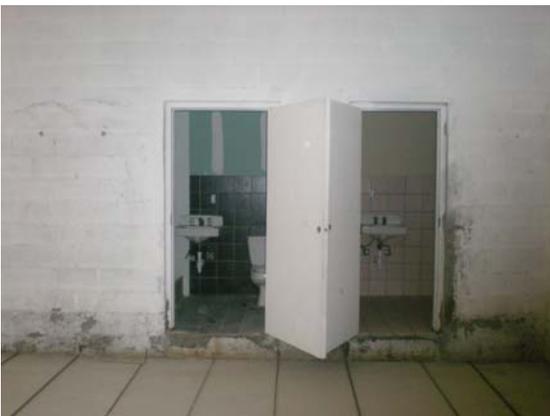
Bathrooms in the right side of the warehouse in the CMU wall that backs up to the showroom. Inoperable shower in rt side bathrooms
